VKM 15216 - VKPC 85624

Technical Bulletin – March 2012

CHEVROLET, DAEWOO, OPEL, SAAB, VAUXHALL

T0139

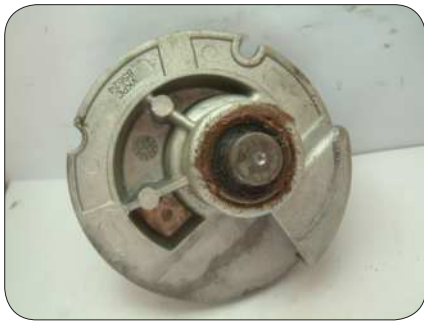
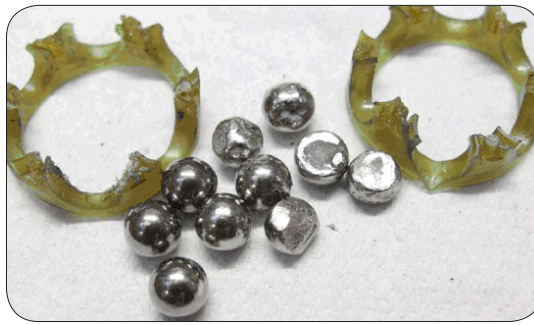
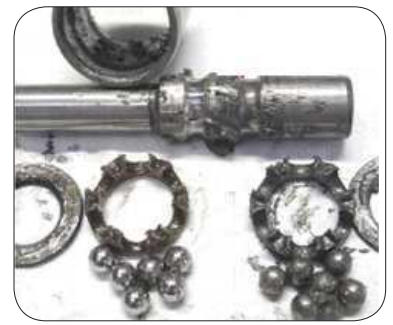
Examples of a damaged water pump:

- Failure of the water pump pulley.

- Over-tensioning of the timing tensioner.
- Incorrect fitting of the timing tensioner.

The tightening torque of the tensioner bolt (supplied with the tensioner) must be strictly adhered to – If the fitting instructions are not followed correctly, the tensioner back plate, the bolt or the water pump could be damaged or in severe cases even break.
