Reliability bulletin WE 1010

Bearing damage analysis: Identifying installation, in-service, or removal damage

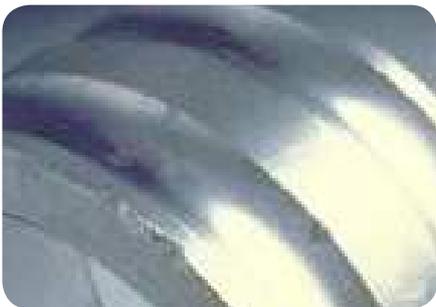
Prevention of future bearing damage depends on accurate identification of the true failure mechanism. The severe damage shown in the first figure was actually caused when the bearing was removed from the shaft. While efforts should be made to avoid destroying evidence, an experienced technician will look beyond this obvious damage for the evidence of in-service or mounting problems that may have limited life.

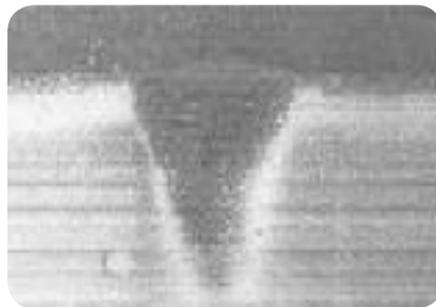
The arrowhead pattern shown in the second photograph is clearly due to improper bearing installation - true brinelling. The typical arrowhead shaped dents are plastic deformation, also called a "true brinell" marks. There's an easy way to separate this type of damage from operational damage:

A true brinell mark will generally show the original machining grooves before, through, and after the damage location. Observed under low power (3x-5x) magnification, the manufacturer's grinding and honing marks are easily seen.

We now have a common language to use in identifying distress, such as brinelling, found in bearings with ISO 15243:2004. Both of these cases fall into the ISO standard category of Damage Classification 5.3: Plastic Deformation, Indentation by Handling but obviously the mechanisms that created the damage are very different.

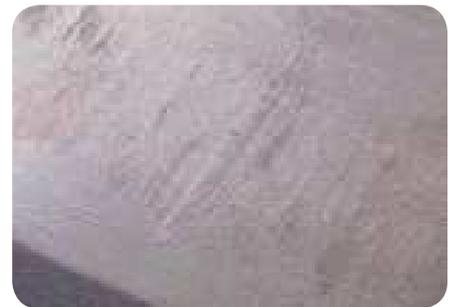
A FALSE brinell mark, (actually a wear process) will not show machining marks in the dented area. Instead, polishing of the dented area, often accompanied by corrosion products (typically reddish or brownish) from the wear process is evident. This falls into ISO Classification 3.3.2: False brinelling. Look for external vibration sources that might have produced these wear marks.

This photograph shows false brinelling on the inner ring of a cylindrical roller bearing.

Understanding the origin of the damage leads to the changes necessary to prevent recurrence.
