Reliability bulletin WE 1010

Bearing damage analysis: Identifying installation, in-service, or removal damage

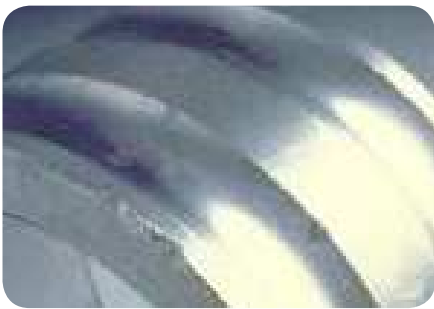
Prevention of future bearing damage depends on accurate identification of the true failure mechanism. The severe damage shown in the first figure was actually caused when the bearing was removed from the shaft. While efforts should be made to avoid destroying evidence, an experienced technician will look beyond this obvious damage for the evidence of in-service or mounting problems that may have limited life.

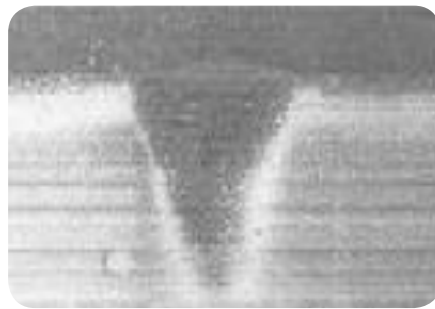
The arrowhead pattern shown in the second photograph is clearly due to improper bearing installation - true brinelling. The typical arrowhead shaped dents are plastic deformation, also called a "true brinell" marks. There's an easy way to separate this type of damage from operational damage:

A true brinell mark will generally show the original machining grooves before, through, and after the damage location. Observed under low power (3x-5x) magnification, the manufacturer's grinding and honing marks are easily seen.

We now have a common language to use in identifying distress, such as brinelling, found in bearings with ISO 15243:2004. Both of these cases fall into the ISO standard category of Damage Classification 5.3: Plastic Deformation, Indentation by Handling but obviously the mechanisms that created the damage are very different.
