# Excessive wheel flange runout can lead to brake pulsation

TT 10-003

## Tech tip

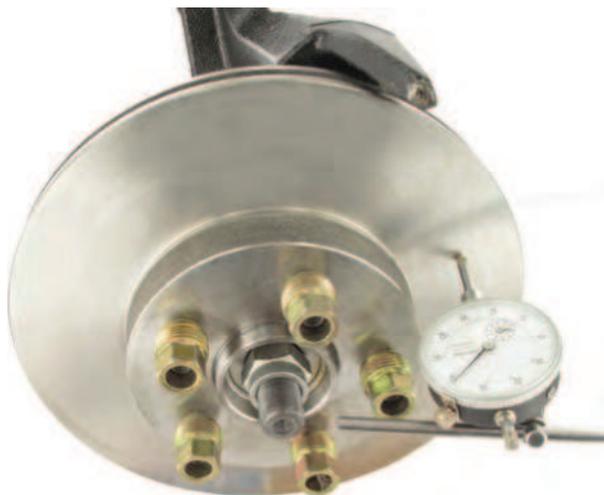
*Fig. 1 Rotor runout*

Because the components of the vehicle work together, a poorly manufactured hub assembly could be the cause of the DTV. Rotor runout measurements and wheel flange runout should be checked to insure the quality of both components. See Fig 1 and 2. The rotor runout relies on the interface of the rotor and hub assembly. Typical rotor runout, as measured

with the rotor mounted on the hub unit, should not exceed 80 microns. Some value line hubs can reach or exceed this limit just on the flange face itself, not considering the contribution to runout that also comes from the rotor. Therefore brake disc runout on assemblies utilizing value line hubs may be up to 5 times the recommended maximum when they are brand new! You may also have to spend additional time indexing the hub and rotor trying to eliminate DTV.

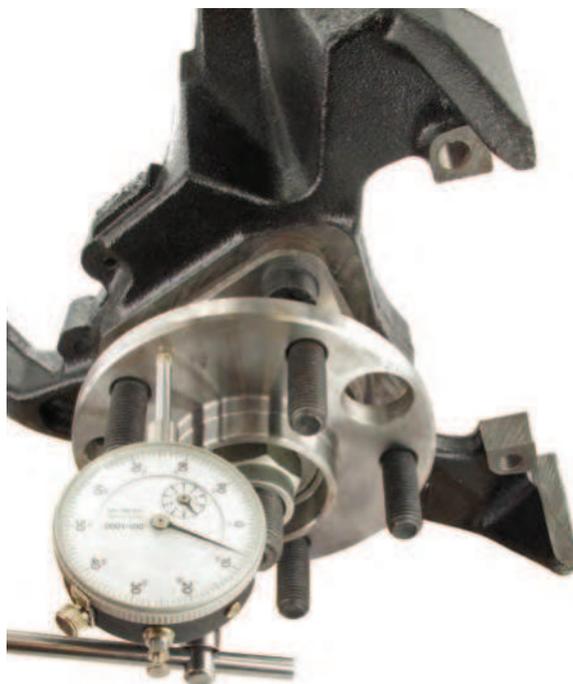
*Fig. 2 Wheel flange runout*

A familiar occurrence is the development of brake disc thickness variation (DTV) over time. DTV is caused by uneven wear of the brake rotor around the pad contact faces. The development of this uneven wear is strongly influenced by the runout of the brake rotor, which in turn is primarily defined by the runout of the hub flange face that mounts to the rotor. If the wheel hub unit runout is high, brake rotor DTV happens quickly. Once this variation reaches 20 microns or more brake pulsation or judder occurs when the brakes are applied. Brake pulsation is easily perceived by the vehicle driver and is the primary source of customer dissatisfaction with brake system performance. If not corrected this can lead to reduced brake system performance and can cause excessive pressure on the hub assembly and lead to premature failure. Even if no immediate failure is noticed for the wheel hub assembly or other braking components the wheel flange runout should be checked.

SKF hub assemblies provide the tightest lateral runout in the market to eliminate any concern with DTV. Choosing premium parts provide the safest choice for your vehicle.
