VKM 15216 - VKPC 85624

Technical Bulletin – March 2012

CHEVROLET, DAEWOO, OPEL, SAAB, VAUXHALL

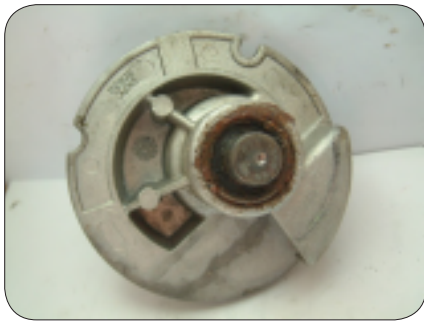
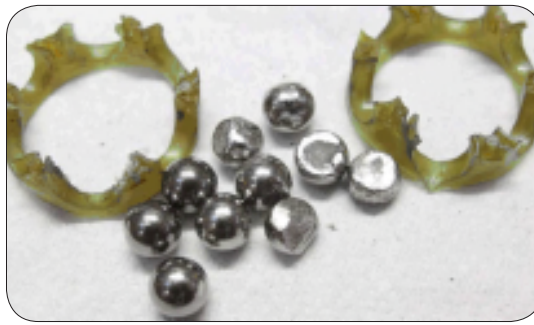
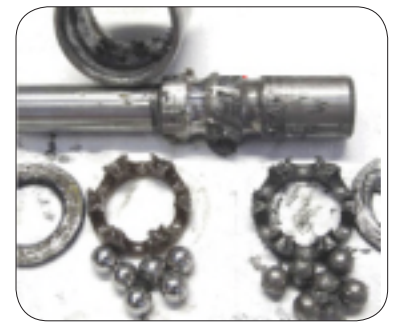
Examples of a damaged water pump:

- Failure of the water pump pulley.

- Over-tensioning of the timing tensioner.
- Incorrect fitting of the timing tensioner.
