Finding Bushing Problem avoids Emergent Stator Swap

Nameplate Information

Motor ID: RCP1-4
 Unit: Unit One
 Model: CS-VSS
 Serial Number: No Name Plate
 Volts - Rating: 11500
 Amps-Rating: 270
 Insulation:
 RPM: 1180
 Frame: 66-SPL
 LR Code:
 NEMA Design:
 NEMA nom Eff: 0
 Manuf's Type
 System: Reactor Coolant
 Manufacturer: Westinghouse
 HP/KW: 6000
 Volts-Operating: 0
 Amps-Operating: 270
 Enclosure: ODP
 Service Factor: 1
 Freq-Hz: 60
 LR Amps: 0
 Max Amb °C: 40
 Duty Cycle:
 Cont.

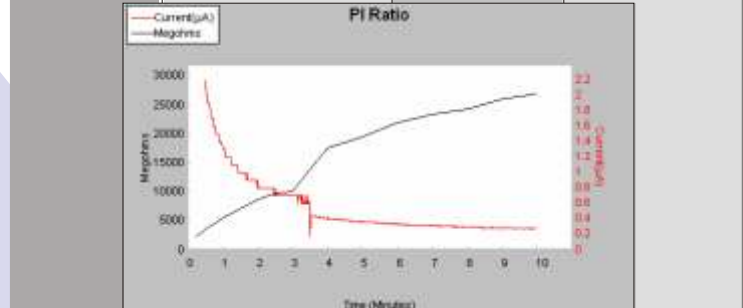
PI Results Graph

Temp Status	Tested	PI Status	Pass
Temp	21.0°C 69.8°F RH 70%	Volts (V)	7000
Resist Status	Pass	DA Ratio	2.9
L1-L2 (Ohms)	0.268 Corr: 0.272	PI Ratio	5.0
L2-L3 (Ohms)	0.267 Corr: 0.270	HiPot	No Test
L3-L1 (Ohms)	0.267 Corr: 0.271	Volts (V)	0
Max Delta R%	0.370%	Current (µA)	0
Coil 1 (Ohms)	0.134 Corr: 0.136	Resist (Mohm)	0
Coil 2 (Ohms)	0.134 Corr: 0.136	Surge Status	No Test
Coil 3 (Ohms)	0.133 Corr: 0.135	Peak Volt (V) L1	0
Megohm Status	Pass	Peak Volt (V)L2	0
Volts (V)	7000	Peak Volt (V) L3	0
Current (µA)	1.30	Max P-P EAR%	0% 0% 0%
Resist (Mohm)	5385 at 40°C 1442	EAR 1-2, 2-3, 3-1	0% 0% 0%

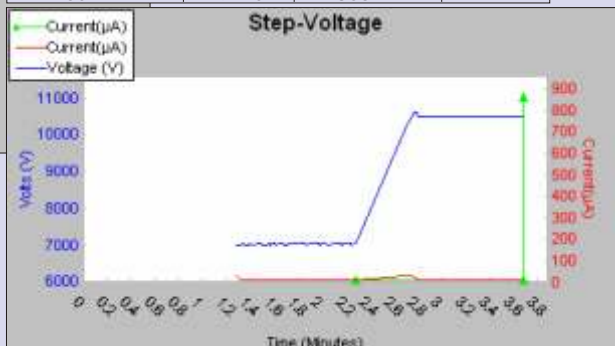
Step Length (Sec)	Volts (V)	Current (µA)	Megohms
60	7070	9	832
60	10500	9	1312
60	9720	863	11

Step Voltage Information prior to repair of bushing.

at 140 feet. This required extension leads to be used to apply adequate test voltage to the motor. These leads were purchased with the instrumentation for testing under these specific type of circumstances. The Step Voltage test failed at just under 10,000

volts. Russ Leatham, Electrical Component Engineer observed the retesting outside the electrical safety boundary at the terminal box. During this retest he observed flashover at the C phase bushing. Testing was stopped, the bushing was inspected and found to be cracked and in fact a piece came loose during handling.

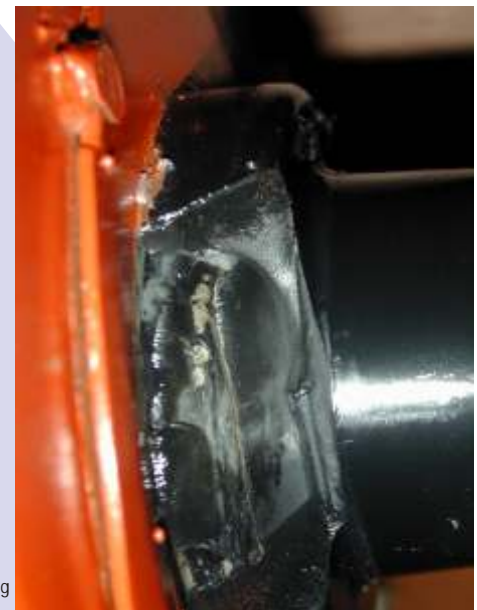
Damaged Bushing

The bushing was replaced and retested with the AWA with good results, including step voltage and surge. Based upon the successful testing the RCP stator swap out was not pursued as emergent work in the current outage (4/2004), but scheduled to coincide with the 10 year overhaul in the next outage (October 2005).

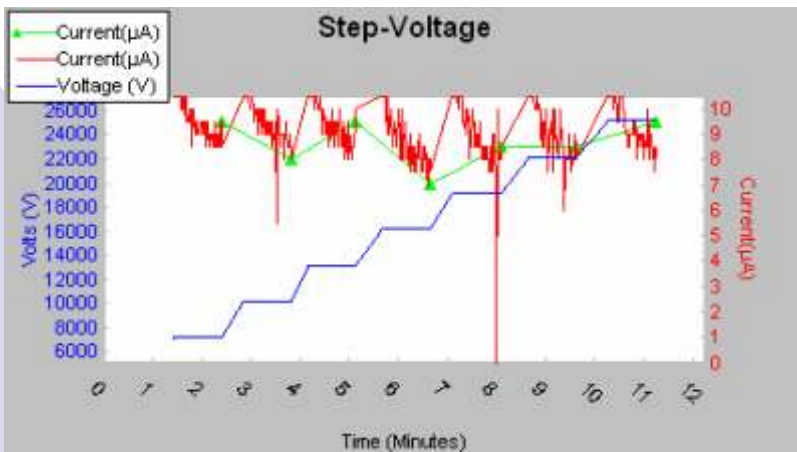
Step Length (Sec)	Volts (V)	Current (µA)	Megohms
60	7280	10	766
60	10200	8	1275
60	13130	10	1382
60	16160	7	2309
60	19190	9	2258
60	22220	9	2614
60	25250	10	2658

Step Voltage Information after bushing repair.

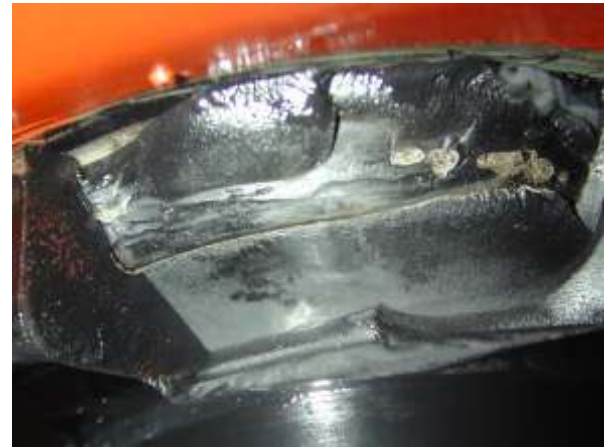
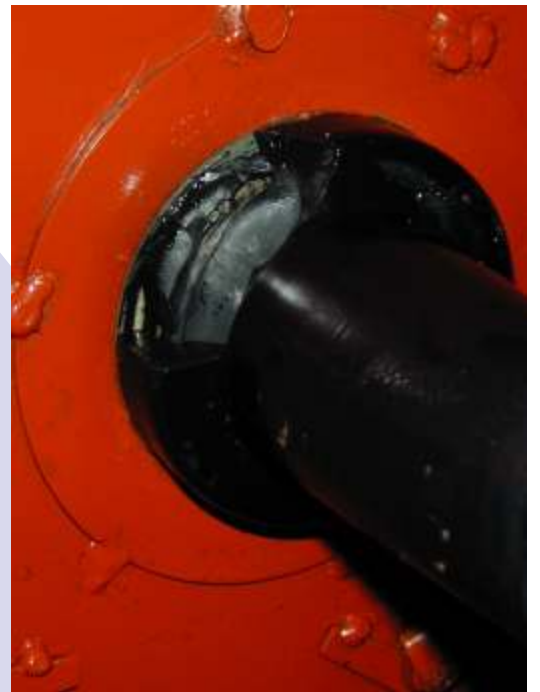
Damaged bushing
