Reduce complaints with correctly mounted HUBs

Fitting guidelines for mounting the VKBA 3496

PUB 80/11 12450 EN.GB • 2012

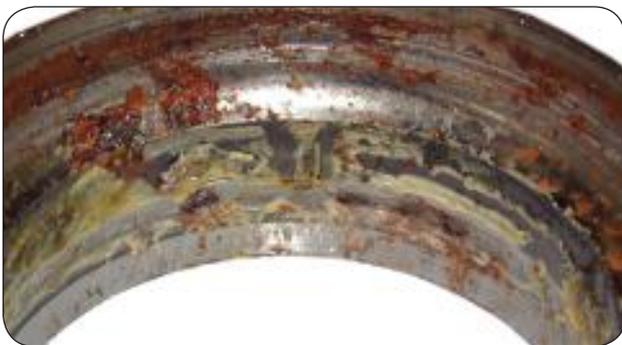
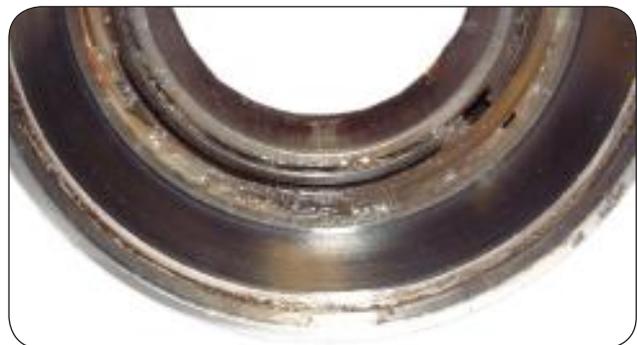
occurs when the incorrect tools are used for mounting the bearing into its carrier. Contact is made with the seal or the inner ring, rather than the outer ring, resulting in the bearing not being pressed vertically into the knuckle. This leads to water ingress into the bearing, misalignment of the rolling elements and flaking, which eventually leads to noise.

Sample pictures of water ingress in a HBU1 type bearing (Generic images – not VKBA 3496)

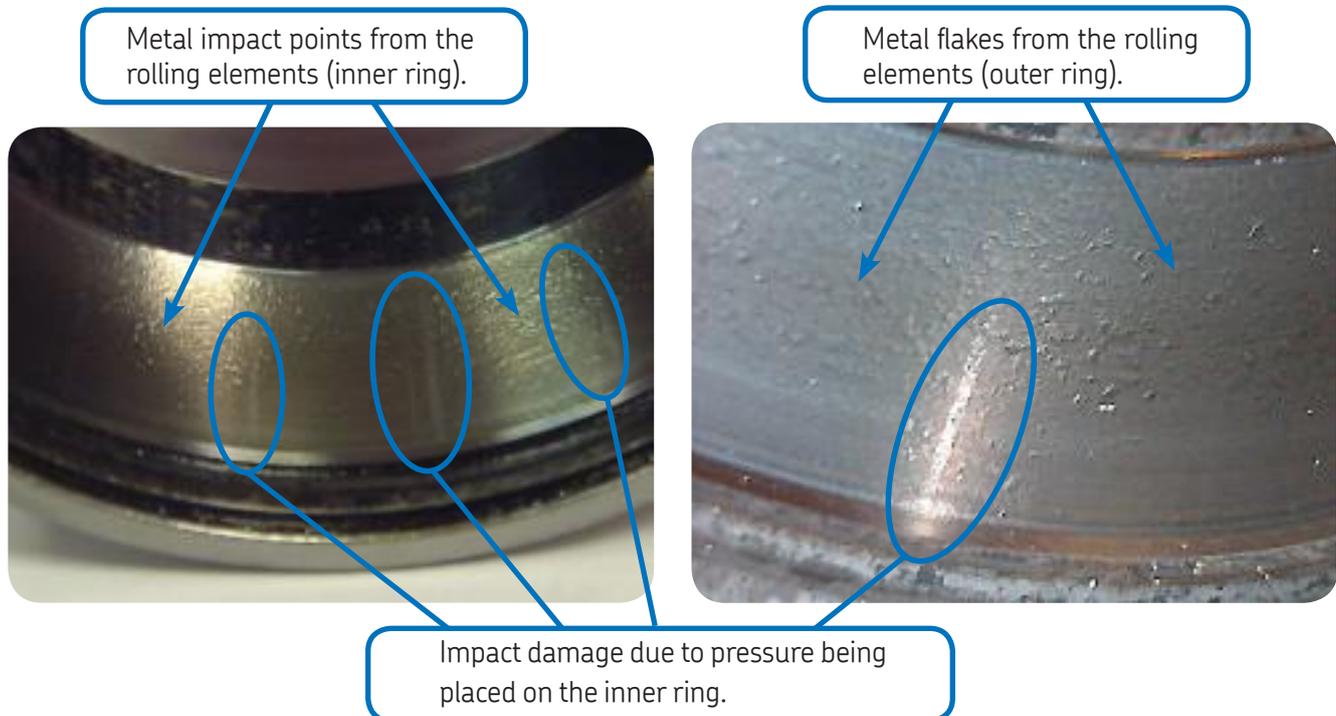
Examples of this type of fitment error are often seen when the bearing is returned under warranty – the following images highlight that pressure has been placed on the inner ring or seal during the installation of the bearing into the knuckle.

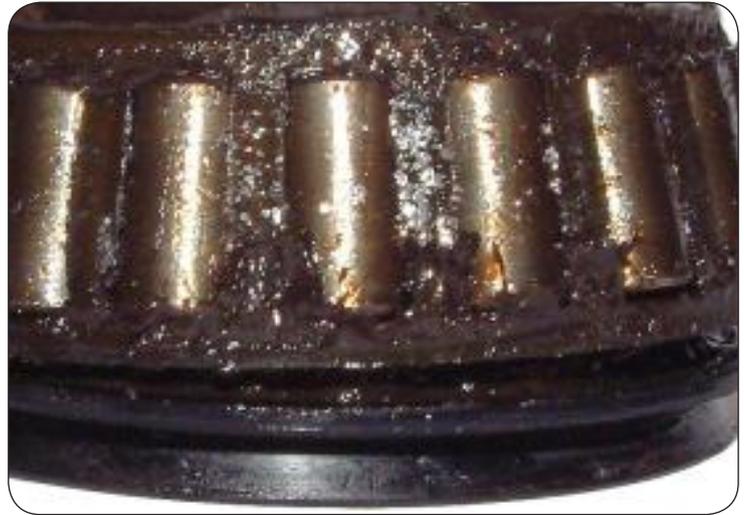
This picture shows the result of a bearing that has been fitted incorrectly. **Note:** the particles of metal flake in the rolling elements and the bearing cage – this will lead to noise and eventually, completely damage the bearing.
