Visual inspection of bearing can establish probable cause of damage

Drying cylinder bearing damage: case 1

PUB 11147/26 EN · August 2019

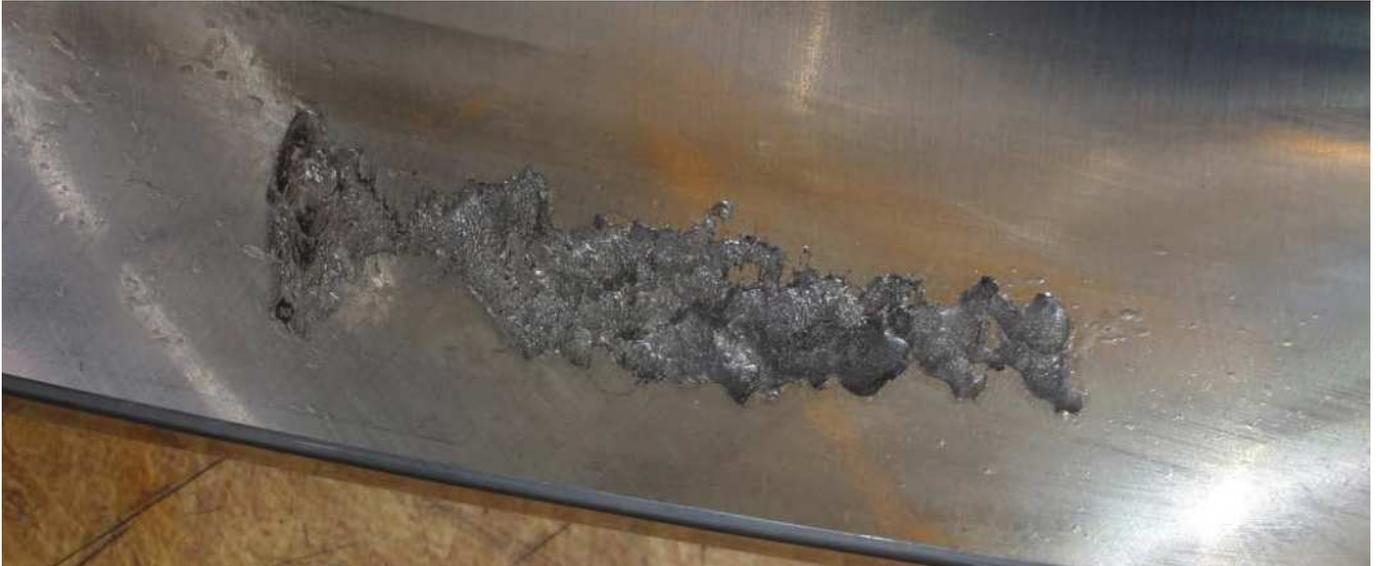
Fig. 1: Bearing damage that doesn't require laboratory analysis.

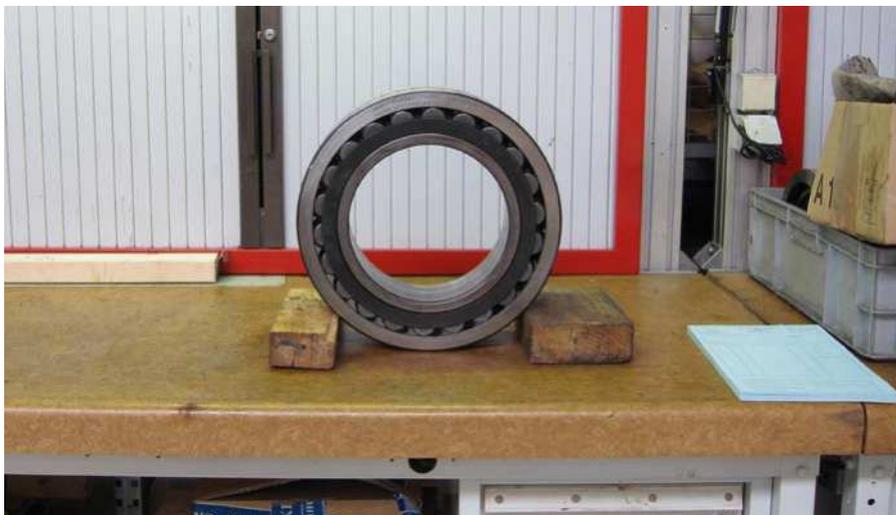
Fig. 2: Complete bearing in quite good condition, ready for investigation.

One year later, the mill sent me a damaged bearing, treating it like a new bearing to avoid causing additional damage that could be misleading. This provided the chance to receive a complete bearing that seemed to be in quite good condition (→ fig 2).

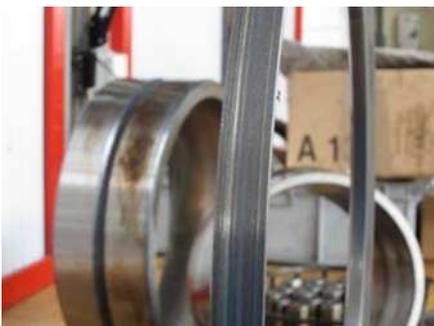
With the exception of the outer diameter (→ **fig 13**), where some slight wear is visible on one side and on the contact between the guide ring and half cage, the guide ring is in very good condition (→ **fig 14**). There is no smearing, and only very slight abrasive wear.

Fig. 13: Outer diameter of guide ring: slight wear.

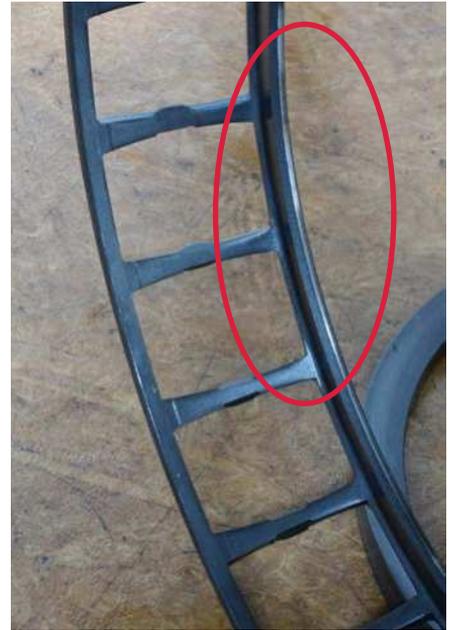
The very first action is to check whether the half cages have signs of wear – in the drying cylinder application, this would point to a lubrication issue. Visual inspection shows very slight abrasive wear in the cage pockets where there is contact with the rollers (→ **fig 15, 16 and 17**). I cannot feel any sharp edges with my thumb (→ **fig 17**), and there is only slight abrasive wear on one half cage – at the contact with the guide ring (→ **fig 16**), and, on the other guide ring, at the contact with the inner ring (→ **fig 15**). Note that sharp edges and/or burrs are created by a lack of lubrication between the roller and the cage. Of course, there is a risk that you could cut yourself, so you must be as careful as when checking the sharpness of a knife with your finger. Unfortunately, the touch-test is often more effective than the visual inspection. There is no adhesive wear (smearing).

Fig. 15: Half cage with slight abrasive wear at its contact with the inner ring.

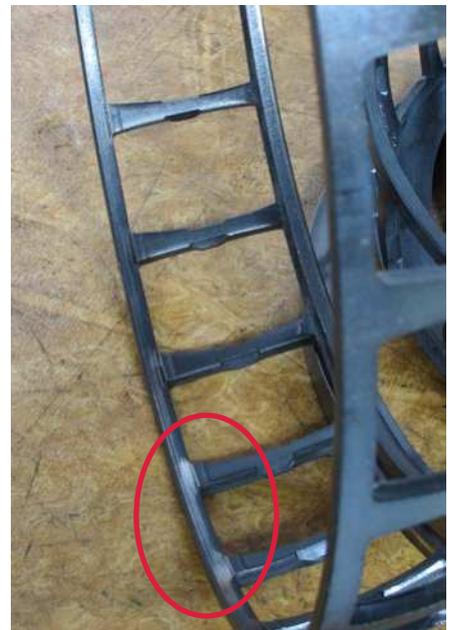
Fig. 16: Half cage with slight abrasive wear at the contact with the guide ring.

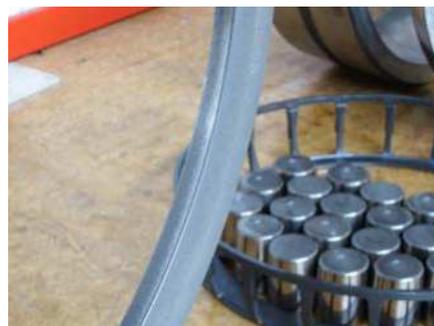
Fig. 14: Face and bore of guide ring: in good condition.

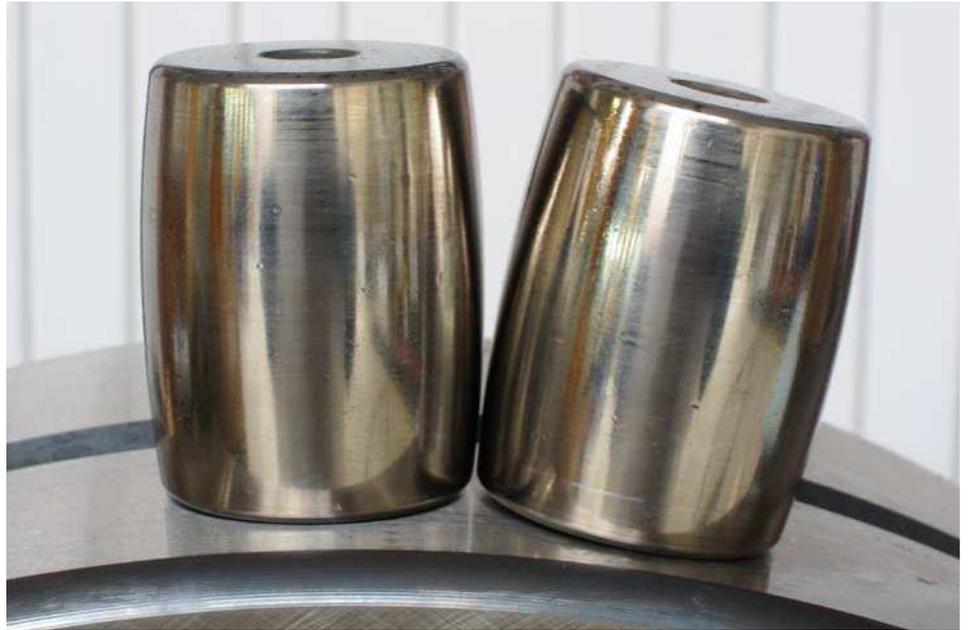
Each roller is visually inspected, revealing that they are in more or less similar condition, with some slight abrasive wear and indentations due to solid hard particles. The rollers on one row have more indentations. Apart from the presence of indentations and some slight circumferential grooves, the rollers are in good condition (→ fig 18).

Fig. 18: : Rollers with slight abrasive wear (shiny appearance) and numerous indentations.

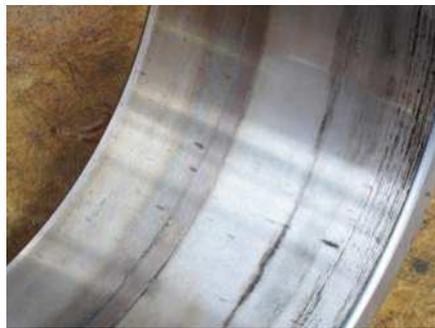
The inner ring bore (→ fig 19) shows some slight fretting corrosion. The shape suggests a slight lack of a tight fit, and perhaps conicity and straightness deviation in the contact, but nothing serious. Small axial smearing marks suggest that the bearing mounting has been performed without oil or with too thin a coating of oil, or that perhaps some small hard particles became trapped between the inner ring and shaft. A reminder about best practices for bearing mounting should be sent to the mill, even if this slight damage has no influence on the bearing service life.

Fig. 19: Inner ring bore. Slight fretting corrosion and small axial smearing marks.

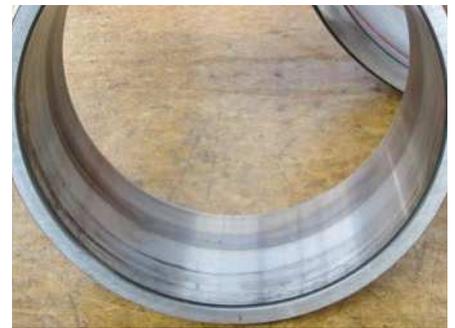
The inner ring faces are in good condition – as good as new for the face on the large bore diameter (→ fig 21), with slight fretting corrosion on the face in contact with the locking washer and locking nut (→ fig 22).

Fig. 21: The condition of the large bore diameter side inner ring face is as good as new.

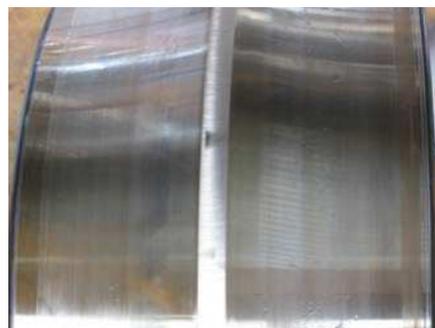
The condition of the inner ring raceways (→ fig 20) is like the roller's condition. What is written above, concerning the rollers, is valid for the raceways and will then not be repeated.

Fig. 20: The condition of the inner ring raceways is like the roller's condition.

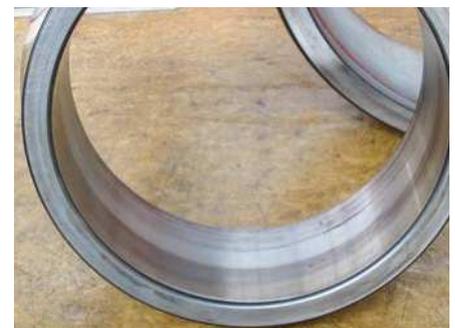
Fig. 22: Small bore diameter side: slight fretting corrosion.

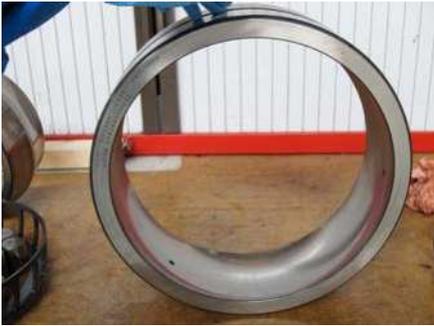
The condition of the outer ring faces
(→ fig 23 and 24) is as good as new.

Fig. 23: Outer ring face, designation side, is in good condition.

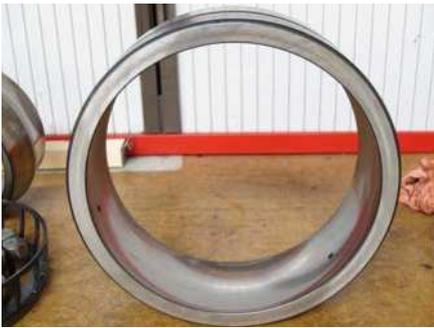
Fig. 24: Outer ring face, opposite designation side, is in good condition.

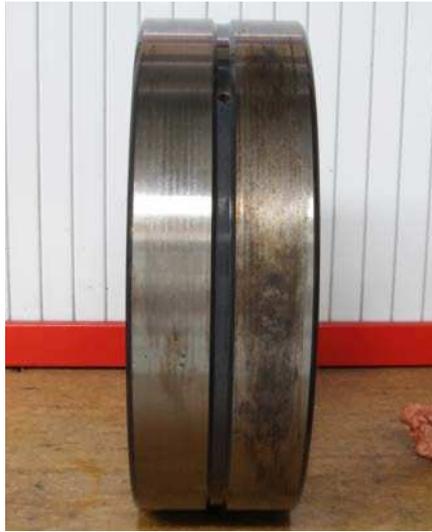
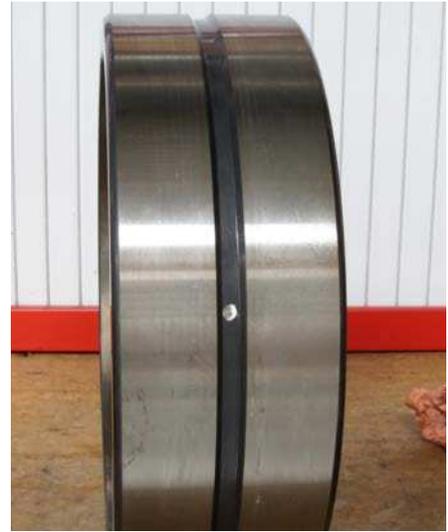
The outer diameter has some fretting corrosion in the loaded zone – this is only slight on one side, but more pronounced on the side that has its raceway with the spall (→ fig 25). In the unloaded zone area (→ fig 26), the outer diameter is in quite good condition. With a loose fit, fretting corrosion cannot be avoided (read Pulp & Paper Practices, issue 16). The intensity of the fretting corrosion depends on many parameters, including load and raceway condition. Is the greater fretting corrosion on one side due to axial load (one row with greater load than the other) and the spall, which increases the fretting corrosion damage? This is possible, but it cannot be confirmed by the spall alone. It is too early to conclude that it is the high axial load, and that the spall is premature fatigue due to the excessive axial load. Such hasty conclusions should be avoided.

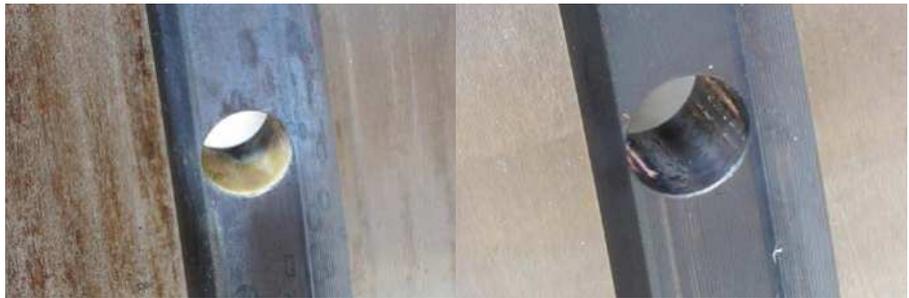
Fig. 27:

Staying with the outer diameter, it is noticed that one of the lubrication holes in the outer ring has some mayonnaise-like substance (→ fig 27), whilst the others are clean.

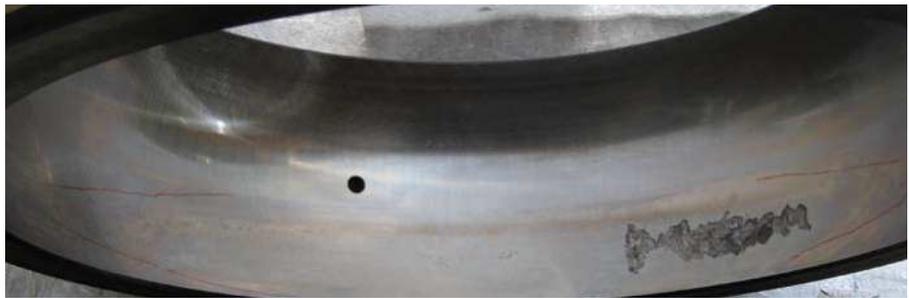
Fig. 28:

With the exception of the spall and the indentations, the outer ring raceways (→ fig 28) look to be in good condition. The grinding pattern from manufacturing can still be seen even in the most loaded zone, and the lubrication is fine. The length of load zone on each raceway is checked to confirm or eliminate the possibility of a heavy axial load. But, as the lubrication is good, it is difficult to be 100% sure where the load zone starts and ends on the raceway which doesn't have the spall. Depending on the light, it appears that the load zone, which doesn't have the spall,

is smaller, confirming a higher load on the raceway which has the spall, meaning that this last raceway takes some axial load in addition to the radial load.

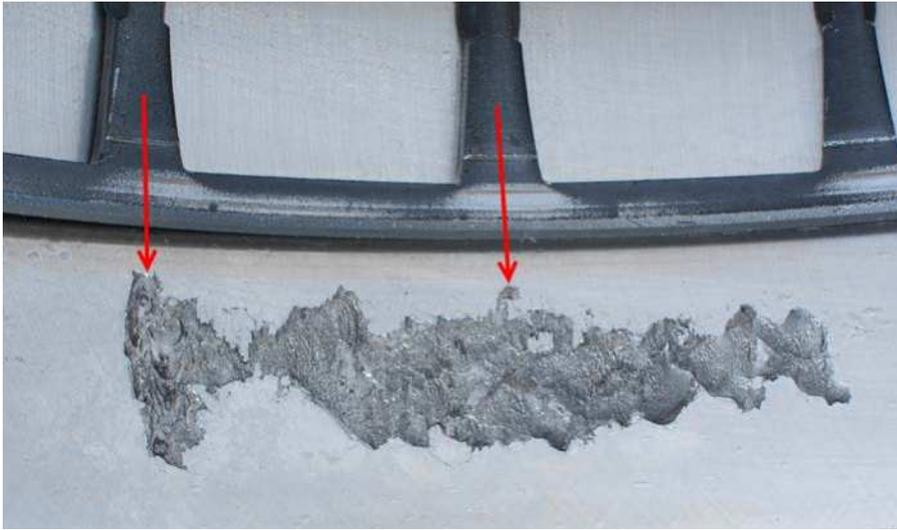
Fig. 29: Spall on the outer ring raceway (cage) can help to discover evidence about damage sustained during standstill.

By placing the cage close to the raceway damage (→ **fig 29**), I can look for clues indicating possible standstill damage, with the main damage being separated by the distance between two rollers. The red arrows show two areas where the primary damage, before the spall, could have occurred.

Note that the right-hand arrow (→ **fig 29**) points to a sort of hook, where sub-surface crack propagation seems to be axial. Another question: position of primary damage? Perhaps, or not.

The main cause of the bearing damage cannot be identified by the visual inspection alone. All we know is that the most probable cause is damage at the roller and raceway contact during standstill – please note that I didn't write "the cause" but "the most probable cause".

Performing corrective actions, including improved water removal from oil by the lubricating system, in order to reduce water content, will stop repetitive bearing failures due to standstill corrosion. However, this will be the case for new bearings mounted after the corrective actions. But you should expect some more bearing failures for those still in service that have previously had contact with free water.

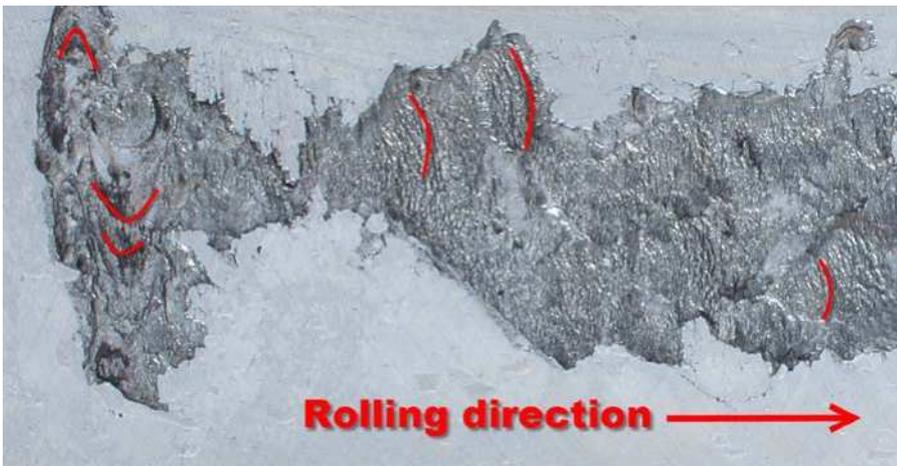
Fig. 30: Primary propagation of the fatigue is in the axial direction, and then in the rolling direction.

It is **Fig 30** that reveals some clues. Normally, on such bearing types, spall created by subsurface fatigue develops in the rolling direction, and not so much in the axial direction. The spall shape shows propagation of the spall from left to right, except for on the far left, where crack propagation is in the axial direction. It is typical in spherical roller bearing failure cases where there has been axial initial raceway damage that the sub-surface microcracks first develop from the damaged area in the axial direction, and subsequently go on to develop in the rolling direction.

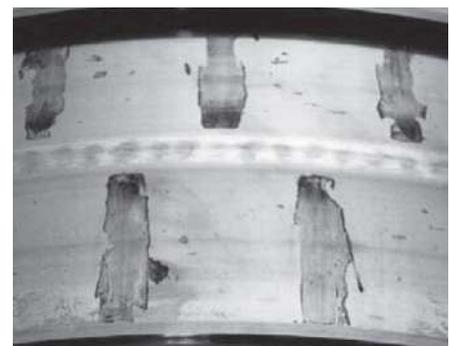
"Fig 32 shows corrosion on the inner ring of a spherical roller bearing under static conditions. The corrosion marks are separated by the same distance that separates two adjacent rollers. There is enough water in the lubricant to cause contact corrosion marks, but not enough to significantly corrode the other parts of the raceways that are protected by the lubricant."

Fig. 32: Standstill corrosion under static conditions.

For the bearing shown in Fig 32, the corrosion marks that are only superficial can be easily worn away. Only the deepest corrosion marks will remain as weak spots, and it is from these that fatigue microcracks will develop, resulting in a spall.
