## Pacific Gas and Electric Corp. troubleshoots mechanical issue using dynamic motor analyzer

### SKF's portable EXP4000 finds root causes of problems with a critical motor at Diablo Canyon Power Plant

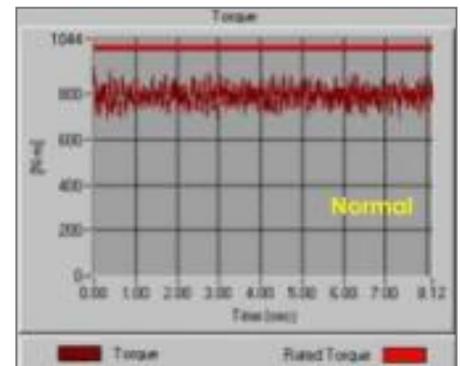
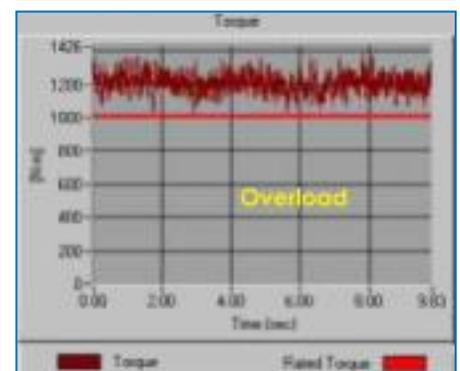
One of the PG&E electricians dealing with the problem decided to gather more information about the motor/machine system before advocating motor replacement. Using an SKF EXP4000 dynamic motor analyzer, the electrician was able to assess torque behavior against the rated torque of the motor. The torque signature displayed by the EXP4000 clearly indicated the 125 hp motor was operating in an overloaded condition.

undergone an impeller replacement just a few months earlier. Closer review showed that the installed replacement impeller was actually larger than the impeller it replaced (17 in v. 15.75 in).

**EXP4000 torque signature analysis.** Normal torque (top image) compared to a torque overload condition signature (bottom image).

The pump underwent scheduled downtime, and the oversized impeller was replaced with the correct part. Once up and running, the motor was tested again. Torque values were properly aligned with rated torque for the motor, and there were no longer any excessive heat or overcurrent issues with the motor.

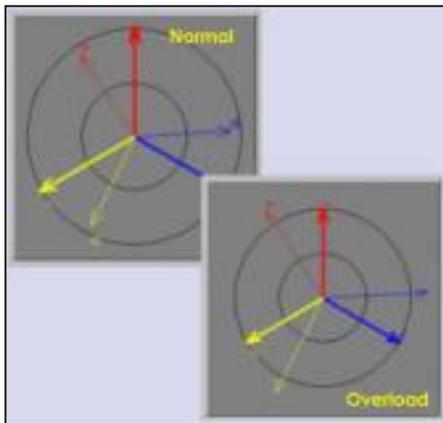
**The EXP4000's phasor analysis of the pump motor.** Normal torque (left) compared to torque overload condition (right).
