Hubcap center-fill plug leakage related to new style hub spindle nut

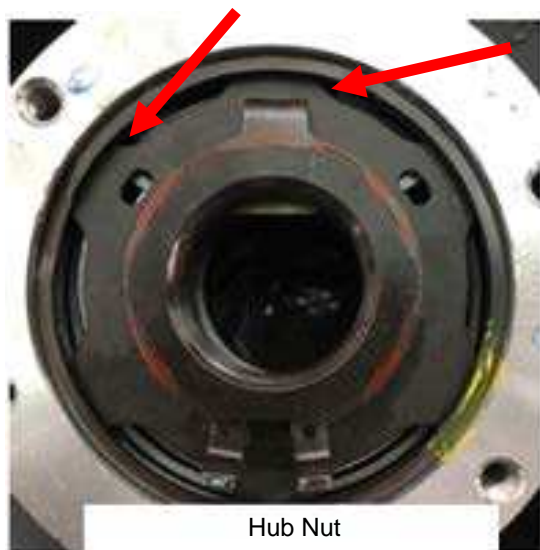
Figure 1

Through laboratory testing, it has been determined that wheel hub assemblies equipped with spindle nuts manufactured with outside diameter tabs, can cause oil leakage with hubcaps that have commonly used center-fill plugs with a standard pressure vent.

It has been determined that the outer edge tabs found on these type spindle nuts creates fluid turbulence that causes oil to be flung toward the center-fill plug during operation, allowing excessive oil weepage.

Hub Nut

Caution should be used when applying hub caps that have the commonly used style center-fill plug, that could weep excessively, when applied to the hub assemblies that use the spindle nut with outside diameter tabs shown in Figure 1.

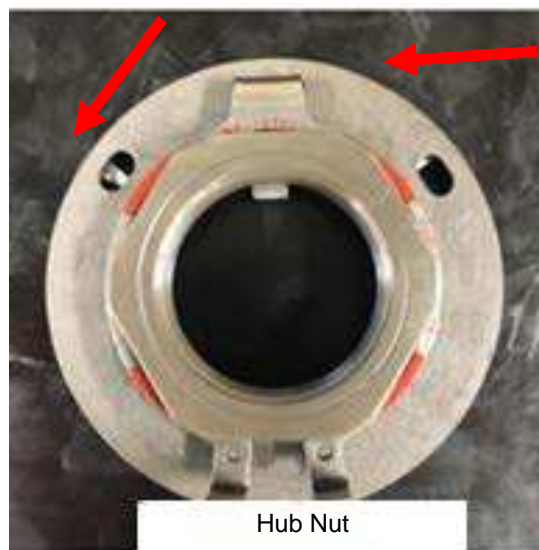
Figure 2

Hub Nut

The standard spindle nut without these tabs does not cause such turbulence.
