SKF Pole Position

Issue 3 · 2010

Replacement of the CV-joint VKJA 3867

CV-Joint replacement guidelines for Toyota Avensis

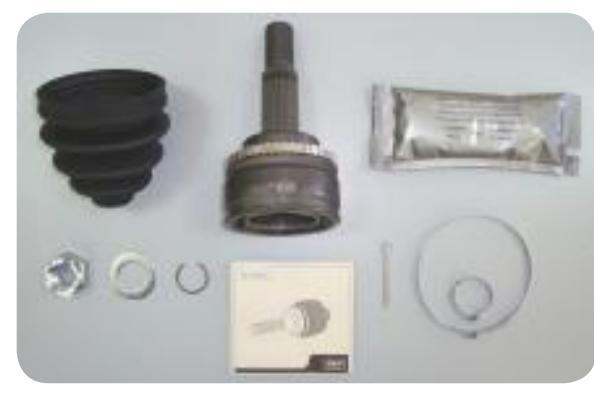
Picture 1: VKJA 3867 kit containing a pre-greased CVjoint, CV boot, short and long mounting clamps, grease bag, circlip, wheel nut, washer and a split-pin.

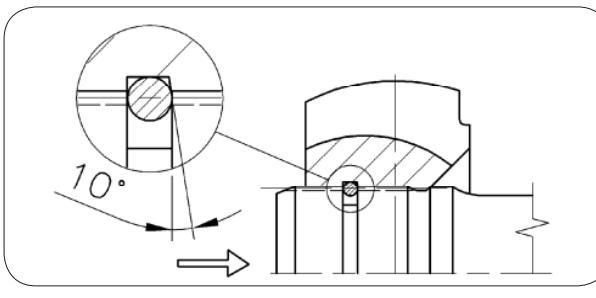
The CV-joint is fitted to the shaft and locked into place by a circlip, which is positioned in a circular groove on the inner race of the CV-joint. The groove in the inner race allows an angular movement of less than 10°, which stops the circlip deflecting out of the groove during the removal phase of the CV-joint from the shaft.

Picture 2: Circlip groove angle

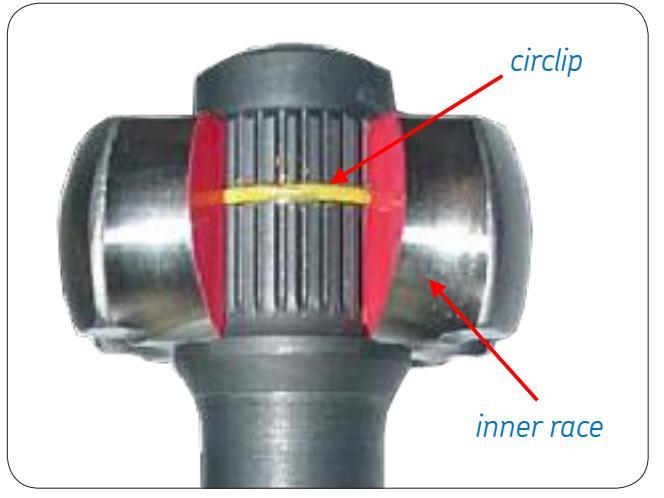
The Toyota Avensis has a CV-joint locked to the shaft by a circlip positioned in the middle of the inner race (see picture 3). The groove in the inner race has a chamfer with an angle that is less than 10°. This design prevents the CV-joint being removed from the shaft by the usual methods of tapping with a hammer on the joint's face, or by using a puller. It is necessary to cut the CV-joint's cage and the inner race in order to remove the joint from the shaft. The replacement guidelines described below relate to the Toyota AVENSIS 1.8 AT221 model, but can also be applied to other applications with a similar CV-joint locking system.

Picture 3: The circlip is positioned in the middle of the inner race
