In this issue of SKF Pulp & Paper Practices, we are going to go through some phenomena which occur on bearing seats due to incorrect tolerances and fits. Wear, fretting corrosion and creep appear very often—too often in my experience with paper mills and root cause failure analysis—and are sometimes considered unavoidable. Not only do they definitively shorten bearing life, they may also cause them to fail catastrophically.

Fretting corrosion and wear in the bearing seat due to ring creep or micro movement

PUB 72/S9 11147/15 EN · December 2015

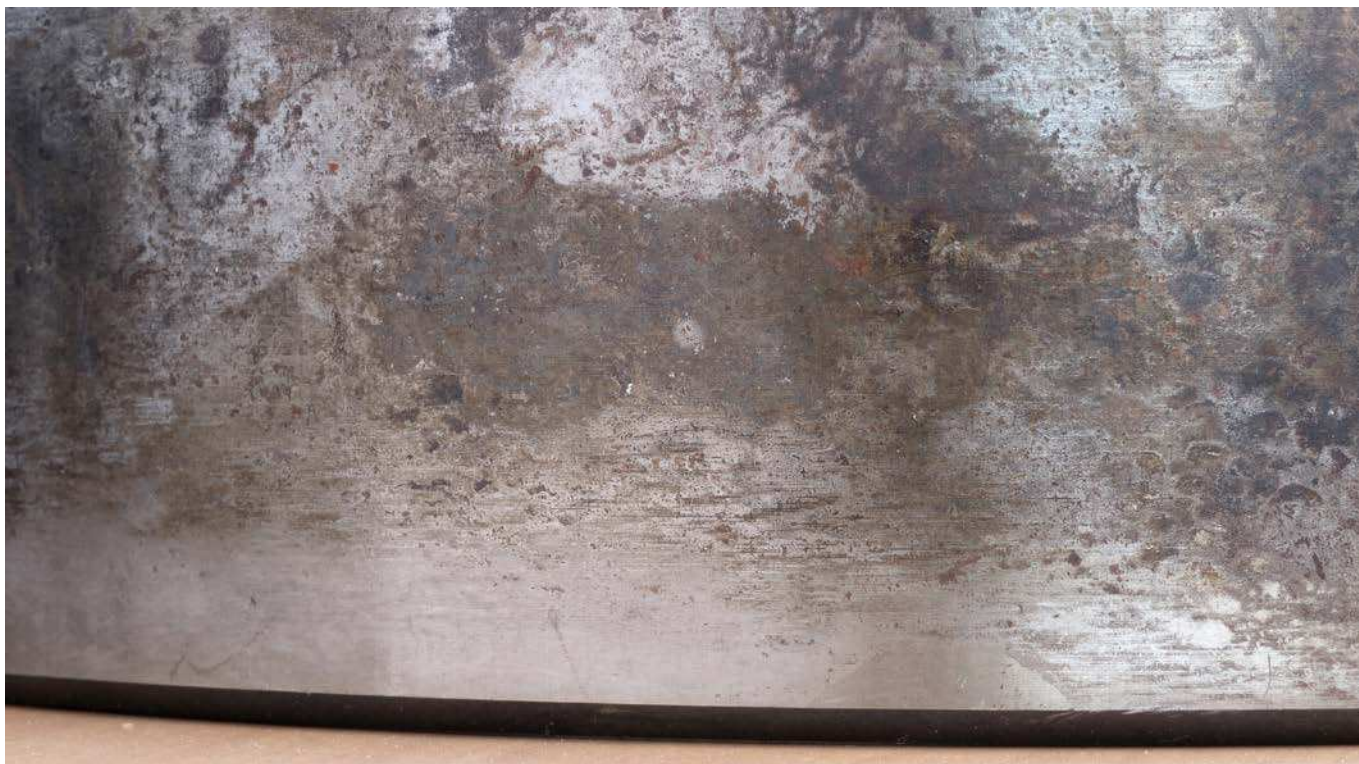
Fretting corrosion on the outside surface of a bearing outer ring due to a damaged raceway

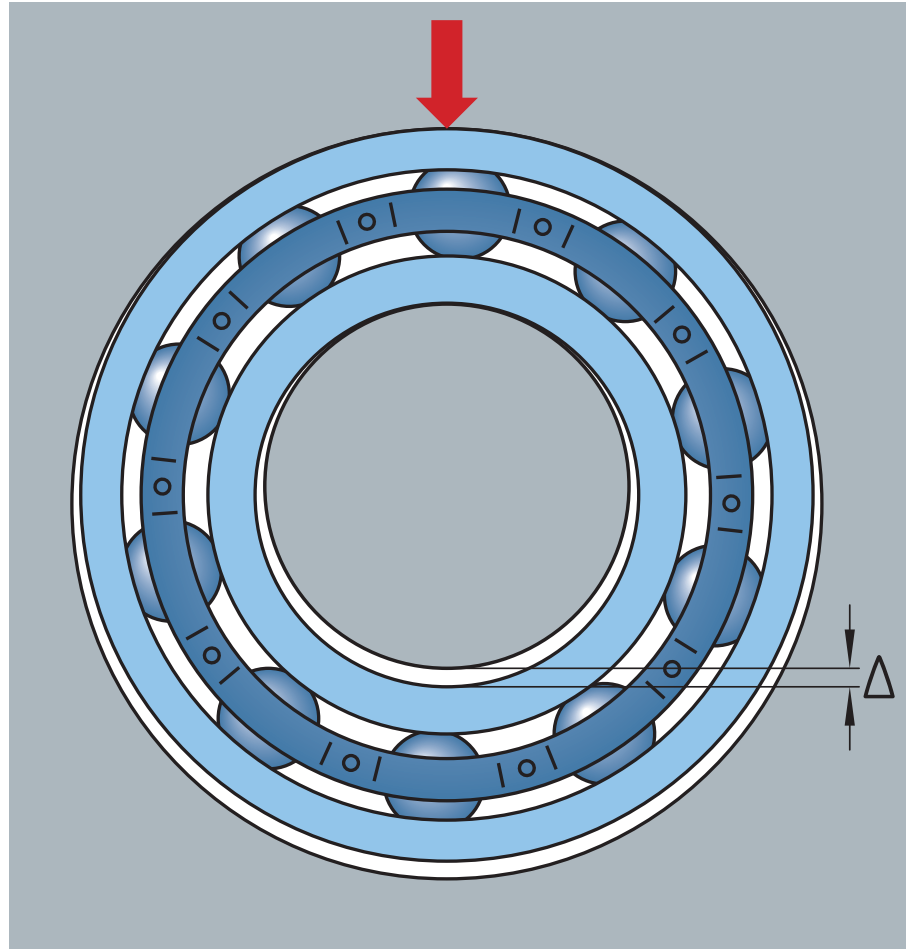
Fig. 2 Bearing inner ring mounted on a rotating shaft while the load has a fixed direction

First, let's look at → **figure 2** which shows a bearing mounted with a loose fit on the shaft. The bearing inner ring is rotating with the shaft and the load on it has a fixed direction i.e. from top to bottom. The contact between the inner ring and the shaft will always be on the top surface of the shaft, but the shaft and inner ring experience rotating load.

With a loose fit and the different circumferences of the mating surfaces, there will be a permanent creeping movement comparable to that found in epicyclic gears.

If the radial clearance Δ of the loose fit is equal to 0.010 mm, the creeping distance is equal to $0,01 \pi = 0,0314$ mm at each revolution. If the rotational speed is 3 000 r/min, the distance after one hour would be 5 654 mm.

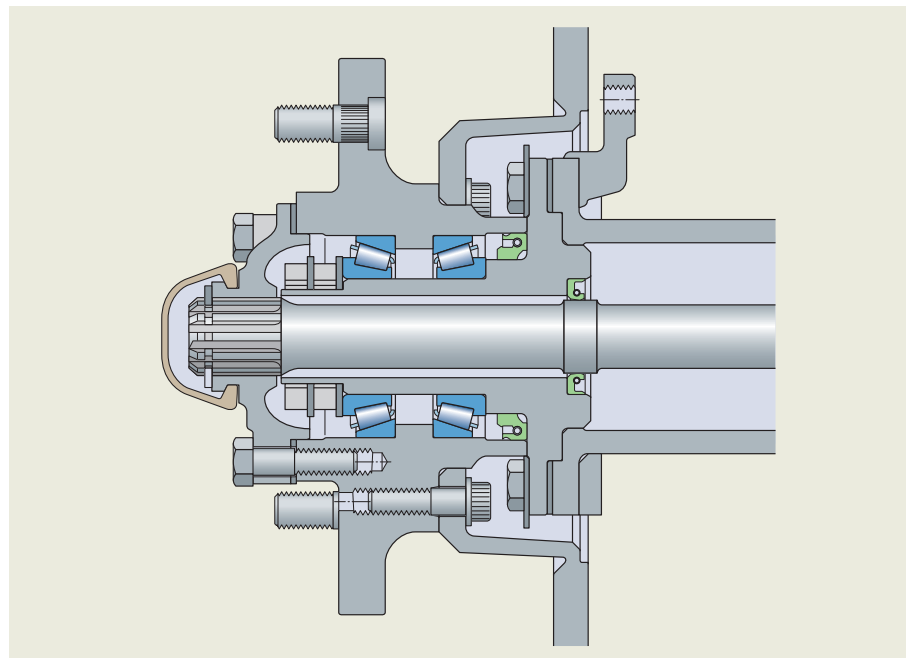
Fig. 3 Bearing assembly in a rear-driven wheel hub

The first example is the wheel bearing stub axle on a four-wheel drive car (→ **figure 3**). The two tapered roller bearings experience outer ring rotation and are mounted with a press fit in the hub. The bearings inner rings are mounted with quite a small loose fit, like a g6, chosen for easy mounting/dismounting and bearing clearance adjustment. Load on the inner rings oscillates around the vertical line depending on torque due to acceleration, speed, braking

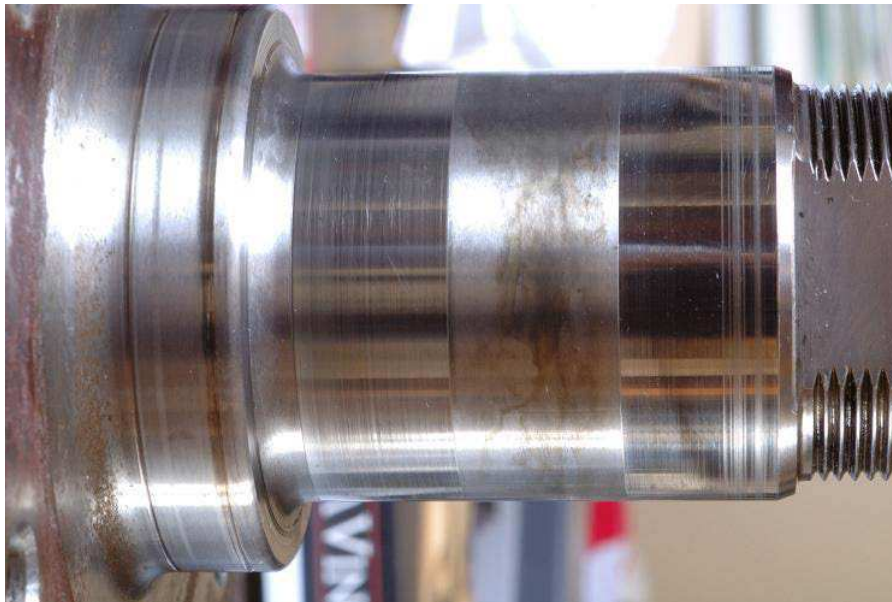
Fig. 4 Wheel bearing stub axle showing wear in the contact surface with the tapered roller bearings due to a loose fit and changing load direction after 200 000 km

etc. The inner rings roll back and forwards on the stub creating wear (→ **figure 4**).

Is this loose fit leading to acceptable wear? I would definitely say yes. After 200 000 km, there was just minor surface wear creating a mirror-like surface with some slight fretting corrosion. After 400 000 km, the wear could be felt with your fingernail, but it was not severe enough to make me decide to change the stub.
