# My fan is running hot!

# Mounting CARB on a fan without a hydraulic nut

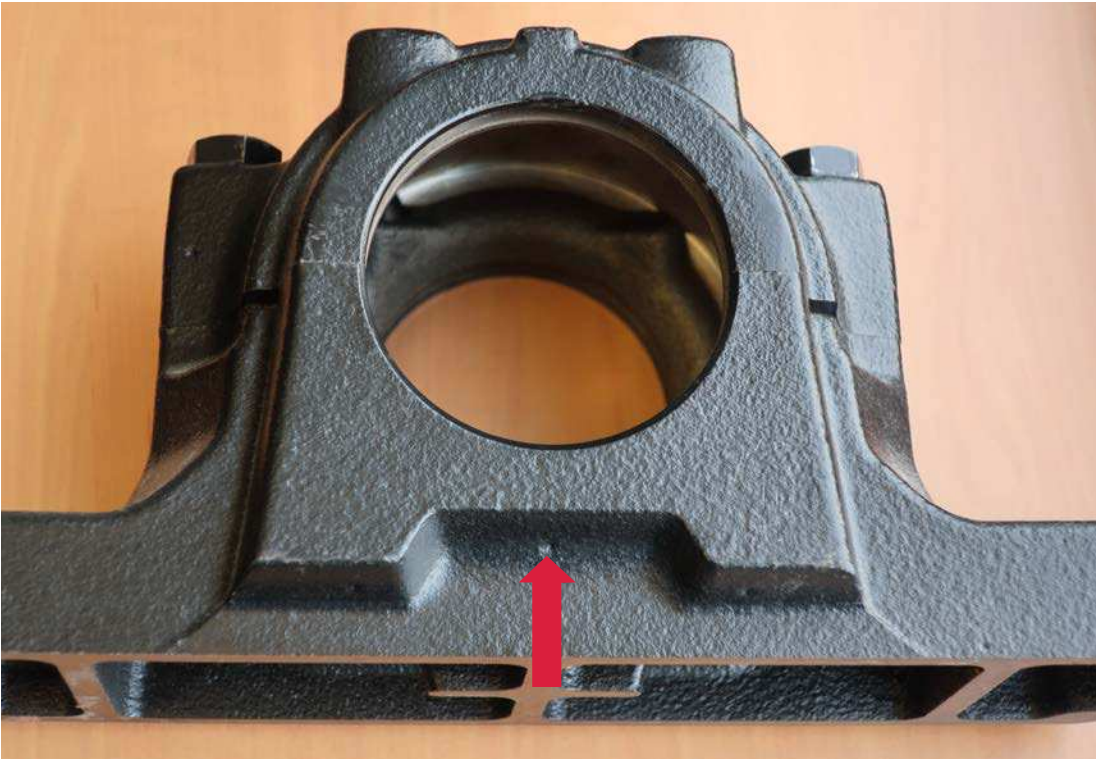
**Fig. 1:** The red arrow indicates the position of the grease escape hole on this housing. Note that the position can vary depending on the housing design used

It is important to check that all bearing housings with grease nipples should have some way of allowing excess grease to escape. If excess grease cannot easily escape through the seal arrangement, the housing should have at least one escape hole. Standard SKF SNL housings can be supplied with one escape hole in the base and will then have the suffix V (see **pages 81, 176 and 215** of the *SKF bearing housings and roller bearing units* catalogue). Customers can, of course, drill the hole themselves if

they want to. In urgent cases without the proper hole dimensions to hand, I just drill a 10 mm hole in the position shown in the photograph on the next page for small SNL housings of series 2, 3, 5 and 6 (see **figure 1**).

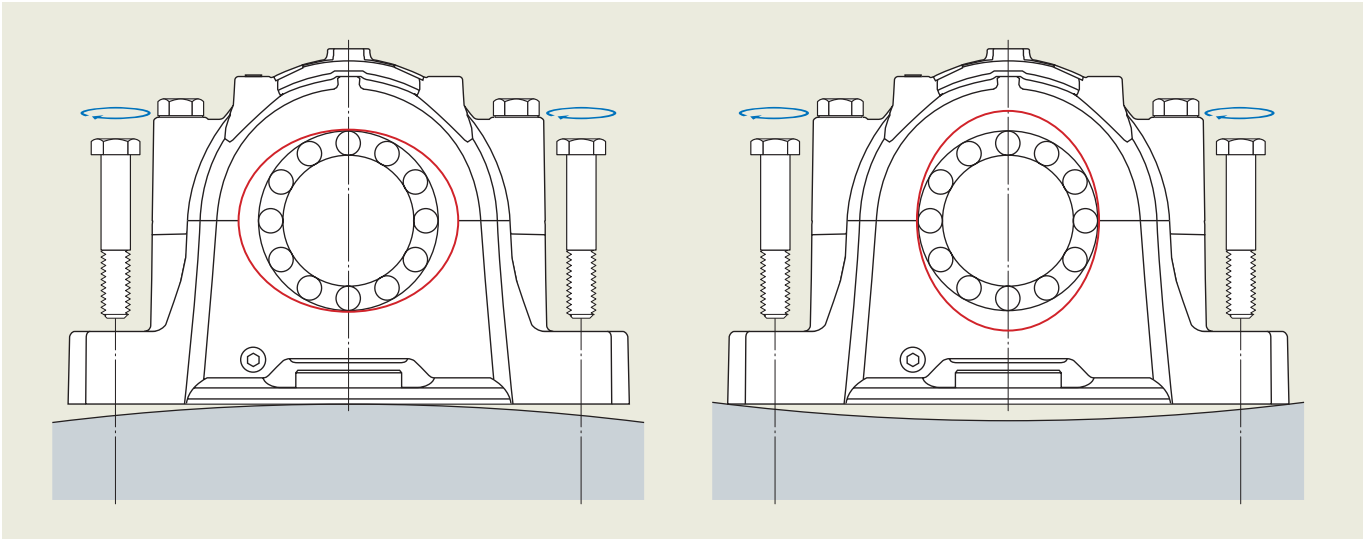
Fig. 2: Housing bores after attachment bolts are tightened

- C** Housing deformation due to poor support. **Figure 2** shows housings on uneven support with the red ovals indicating the

housing bore shape once the attachment bolts are tightened. As you can see, the bearing outer rings are squeezed, become oval and will have difficulty in displacing axially. Note that this can also happen if the housing support is insufficiently rigid and deforms under load. SKF recommends that the flatness of the housing support should be to tolerance grade IT7 in accordance with ISO 1101.

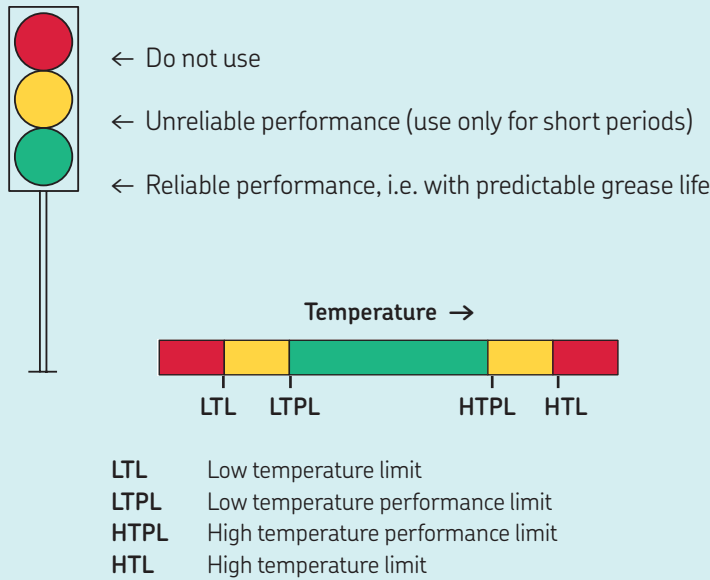
Diagram 1

The SKF traffic light concept

It isn't always easy to find the base oil bleeding tests for grease. SKF provides this information for SKF greases and has created a traffic light concept to check whether a grease bleeds enough oil. With the traffic light concept, this is shown using the Low Temperature Performance Limit (see diagrams '1' and '2')

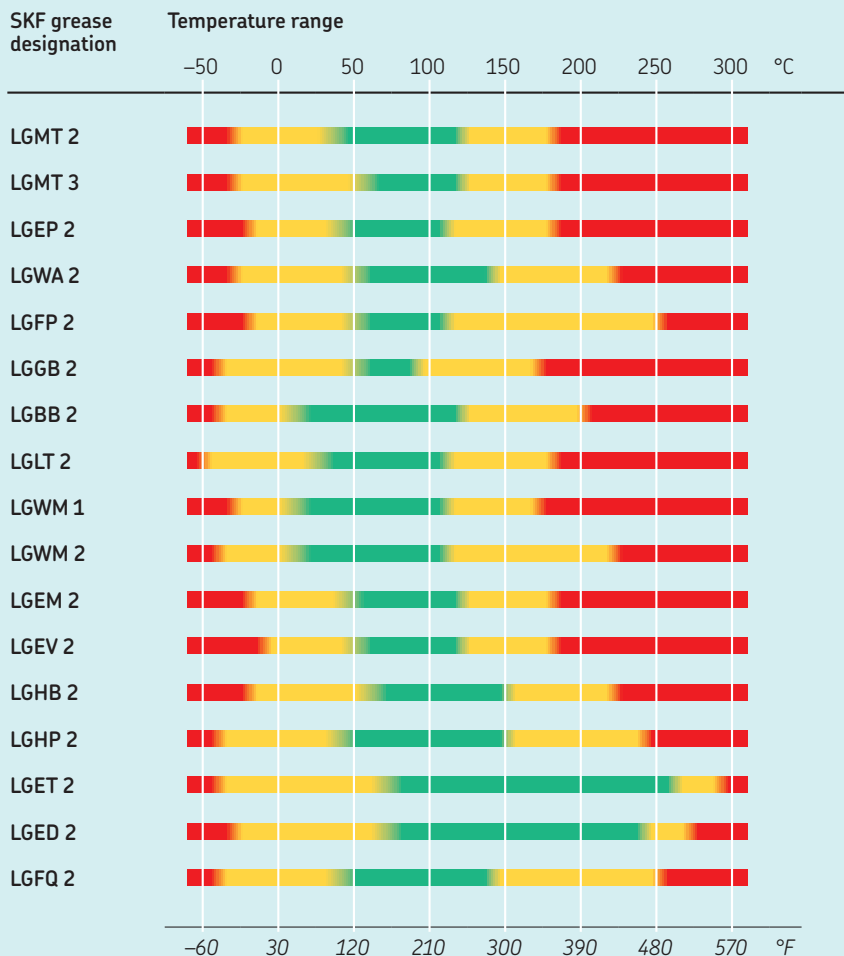
Table 2

Wide high temperature diagram

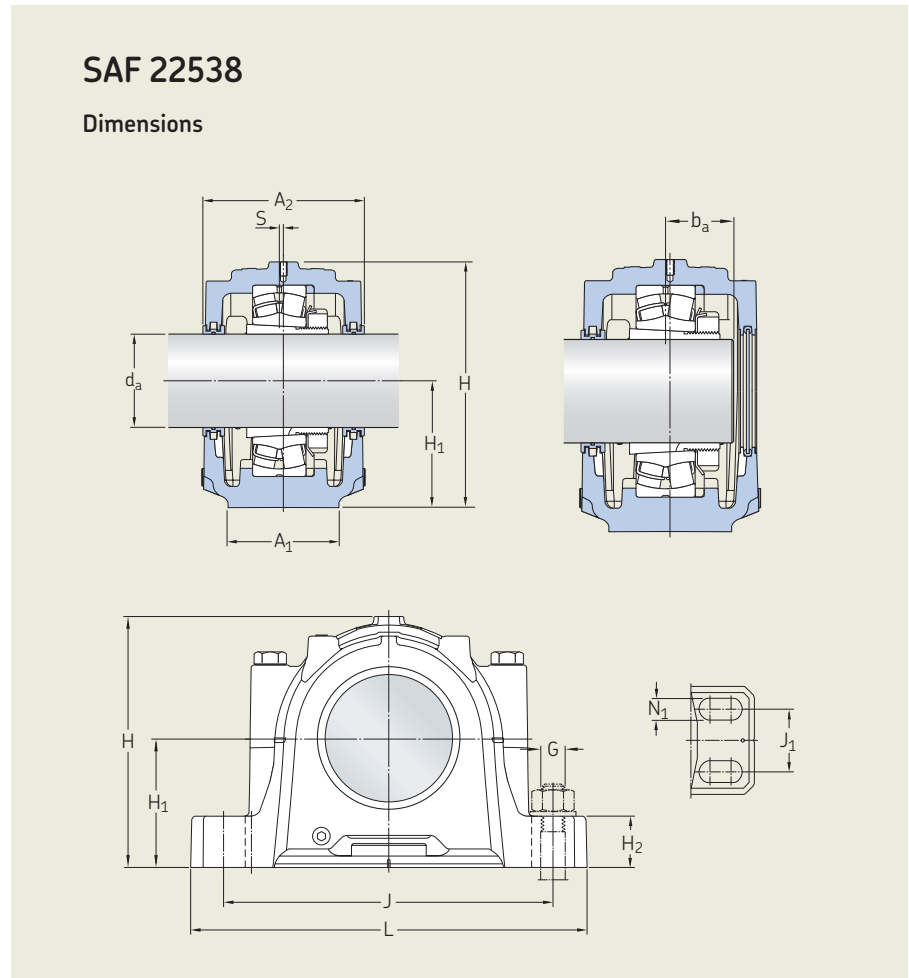
Fig 1: SAF 22538 housing with spherical roller bearing and adapter sleeve

When I was told that I was going to supervise CARB mounting, I'd done SKF Drive-up Method calculations as it's much more accurate than using feeler gauges. I'd envisioned driving up the bearing on its adapter sleeve with a hydraulic nut, but had not taken into account that the housing was a North American SKF SAF 22538 housing used in a fan application (see **figure 1**).

With the SKF SAF 22538 housing, the shaft needs to be lifted around 160 mm to be able to remove or place the housing base with the bearing mounted in its operating position on it. Sometimes it's not even possible to replace the lock nut without removing the bearing and housing from the shaft. In this case, the shaft could not be moved more than 4 mm in all radial directions. So, the only way to replace the bearing without touching the fan casing was to:

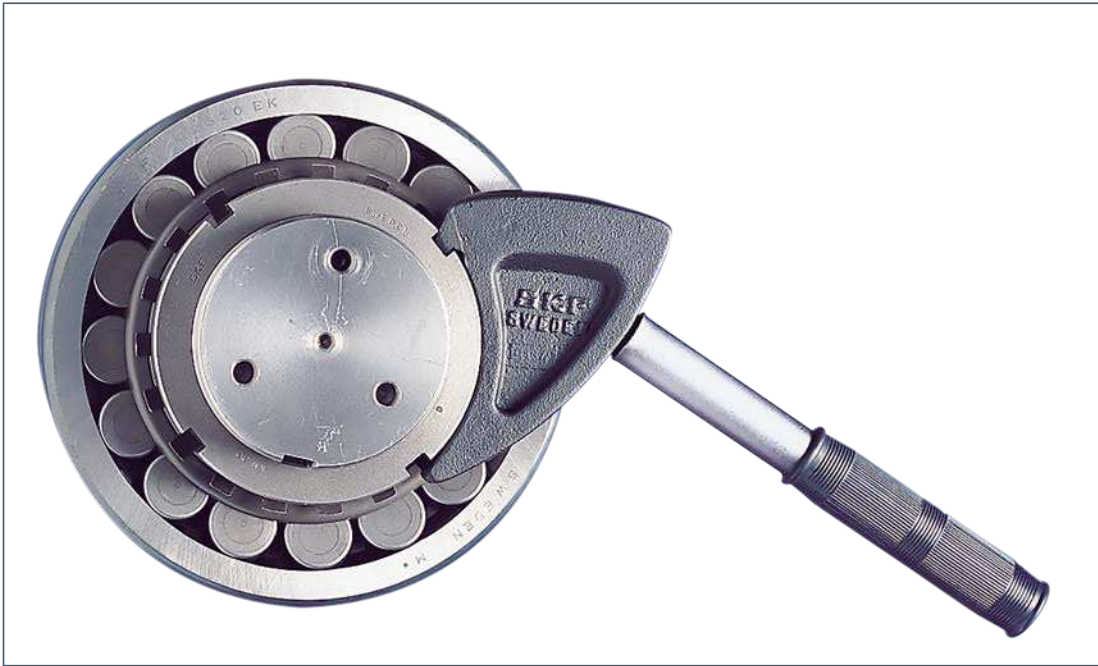
Fig 2: Impact spanner

Since it not possible to mount a bearing with a hydraulic nut with the housing base already in position, the SKF Drive-up Method cannot be used. The only way is to turn the lock nut to force the inner ring up its seat on the adapter sleeve. To avoid damaging the lock nut and potentially the locking washer, it's best to use an impact spanner and a hammer to do this (see **figure 2**). In the case in question, a customer owned impact spanner was used.

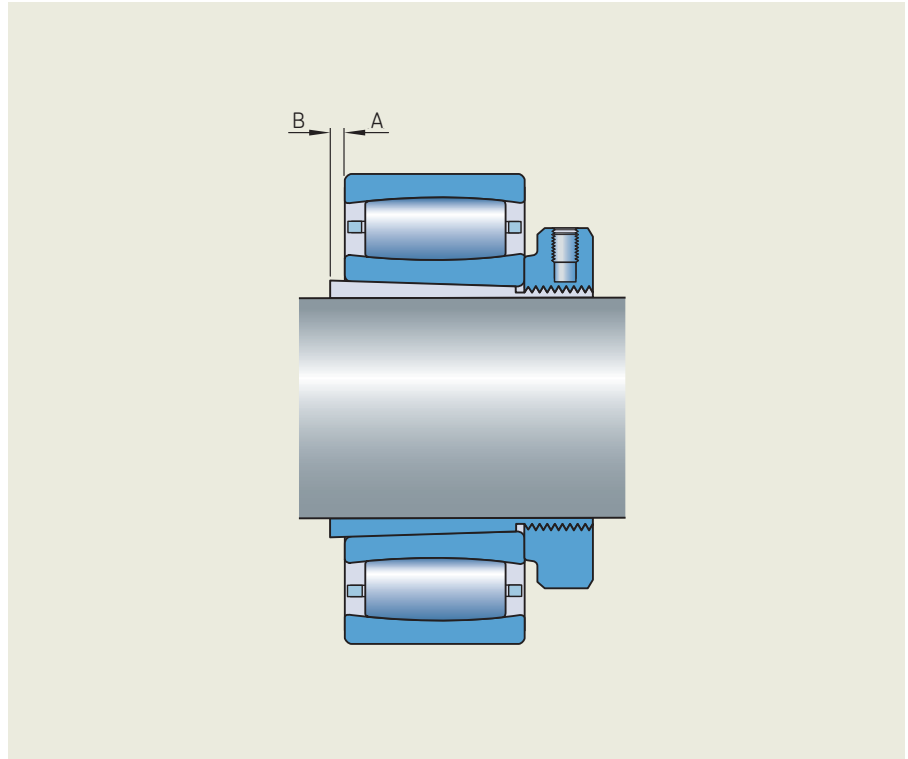
Fig 3: The distance A-B. N.B. The lock nut shown is not the one used in my 1997 fan case

Secondly, using the distance of the bearing drive-up along its seat measured with a dial indicator or another suitable tool. In my fan case, I used two reference planes: the bearing inner ring face 'A' and the adapter sleeve end face 'B' (see figure 3). We used Johansson gauges, that when wrung together would give the distance A-B, together with a small straightedge against the sleeve face to help increase the accuracy of the measurement. We then subtracted 1,80 mm from the A-B distance and wrung together Johansson gauges to the new calculated value  $((A-B)-1,80)$ . We then drove the bearing up its seat until the Johansson gauges placed on bearing face A touched the straightedge against adapter face B. I don't recall why we used this method instead of a dial indicator. Maybe it was the lack of space.

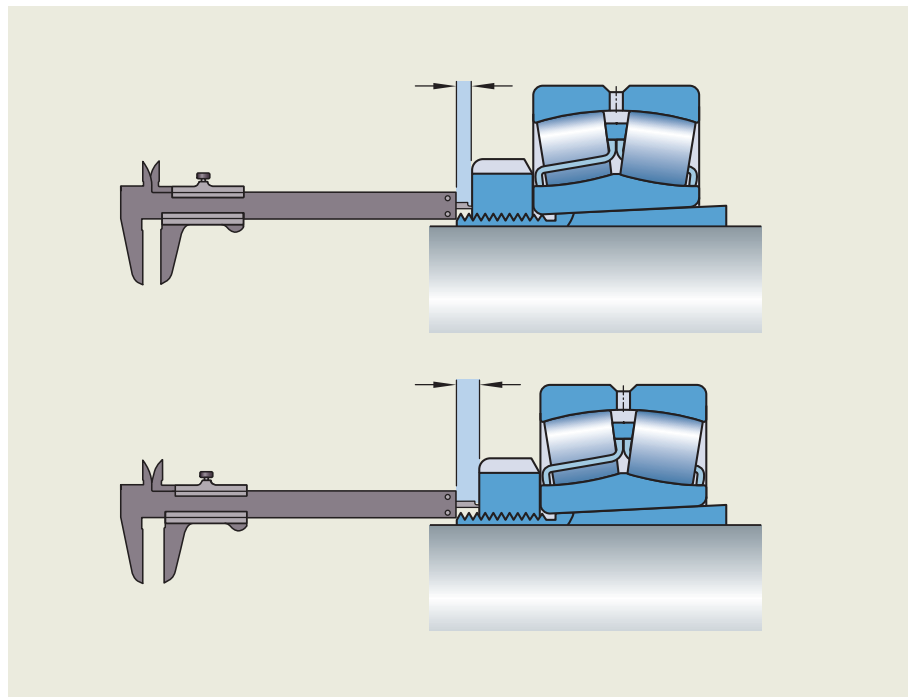
Fig 4: Measuring axial drive-up with a Vernier caliper

There are some other ways of measuring axial drive-up. For example, the one shown of page 56 of the *SKF bearing maintenance handbook* (see figure 4).

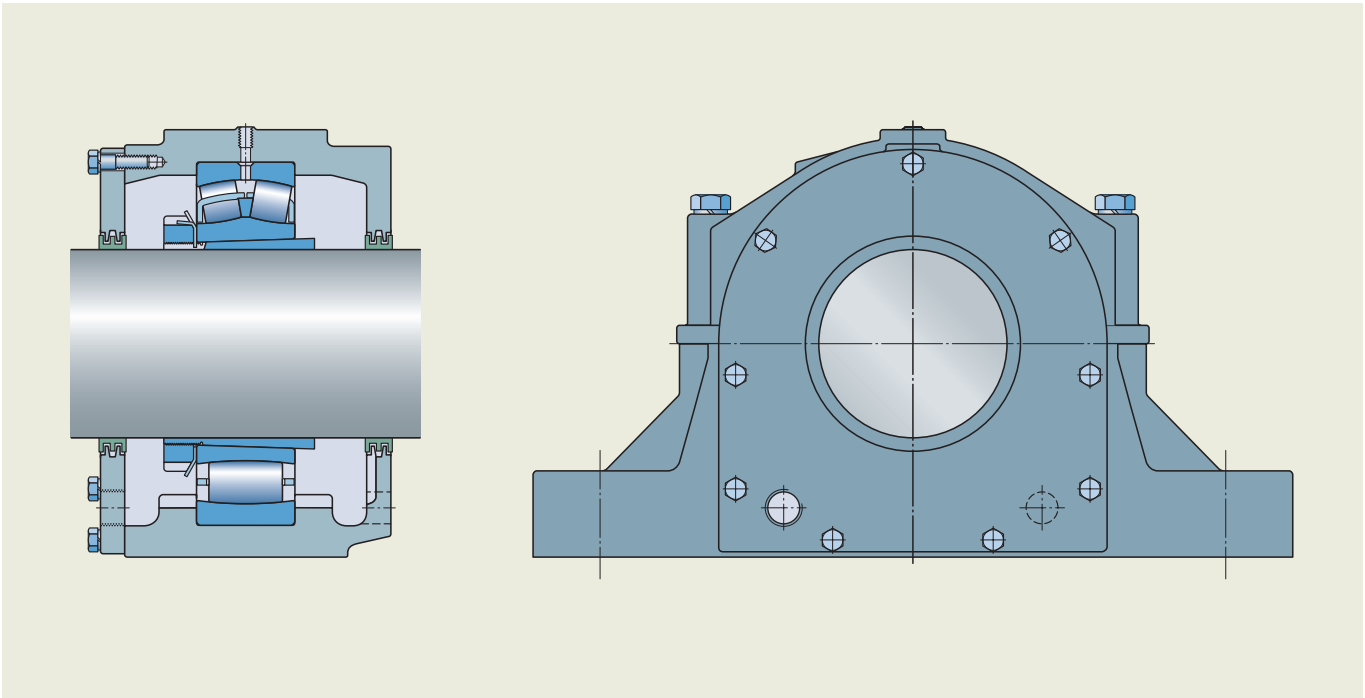
Fig 5: Customised SAF housing for use with a hydraulic nut on the TAD fan at the mill

Understanding that it wasn't as easy to mount a CARB bearing with a feeler gauge compared to a spherical roller bearing and convinced about the SKF Drive-up Method, the mill manager asked for a housing that could be used with a hydraulic nut which could replace existing housings without any modifications. A modified SKF SAF 22538 with an end cover added was proposed and accepted (see figure 5).

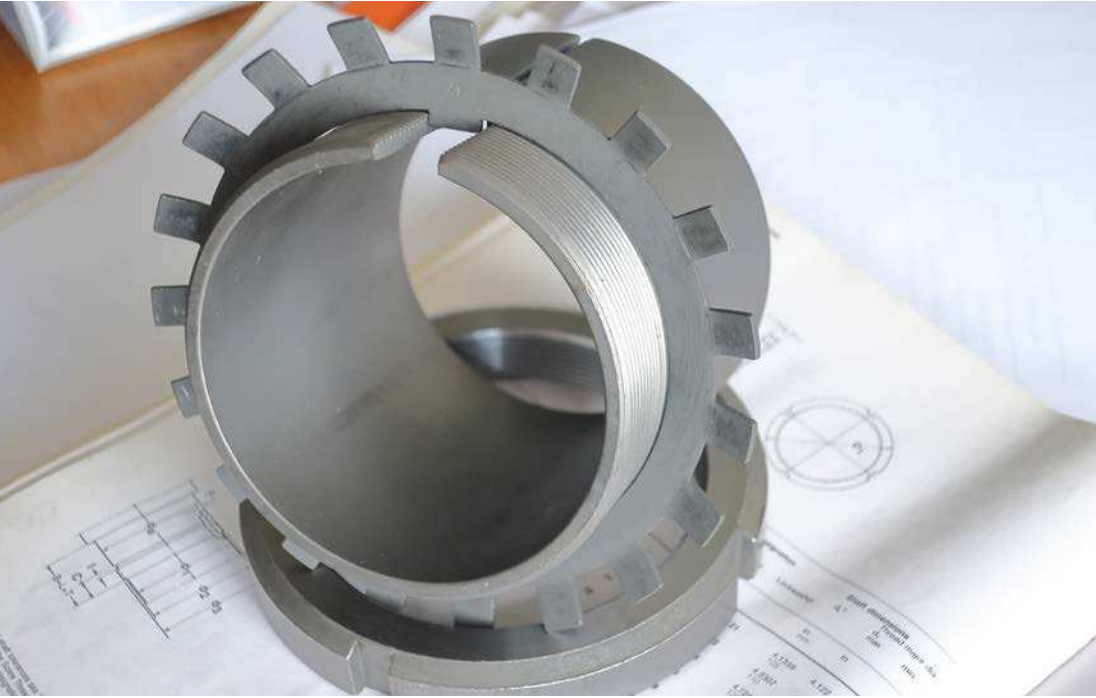
*Fig 6: Locking washer in position on the adapter sleeve*

SKF does not recommend mounting a lock washer between the nut and the bearing during drive-up, but it's not possible to remove the lock nut once mounted to place the washer in some applications. The reason for this is that the locking washer has an inner tab that is positioned in the adapter

sleeve slot (see figure 6). The washer doesn't rotate, but the nut rotates against it with high axial force during drive-up and the friction between the two tries to move the washer. This can damage the washer's inner tab and even tear it off. There is a risk that the washer becomes free to rotate thereby losing its locking function.
