# SKF rope sheave units

Improve machine reliability with SKF rope sheave units

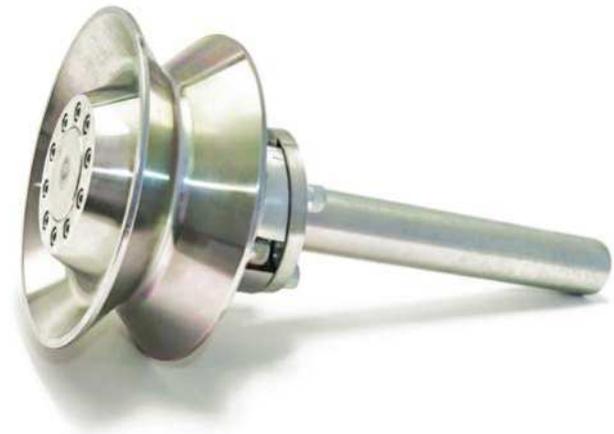
SKF offers a unique solution that makes rope sheaves virtually maintenance-free.

The units are based on SKF wheel hub units which perform well even under the harshest conditions. A special grease is also included. Both the unit and bearings are sealed for life, eliminating the need for grease nipples or lubrication ducts that could leak.

The units are zinc coated to resist corrosion. Finally, the addition of a patented security device locks the unit firmly in place and prevents it from falling off the shaft, even in the unlikely event of bearing failure.
