Customer reference case

SKF filament wound bushings

Filament wound bushings increase MTBF for Herder

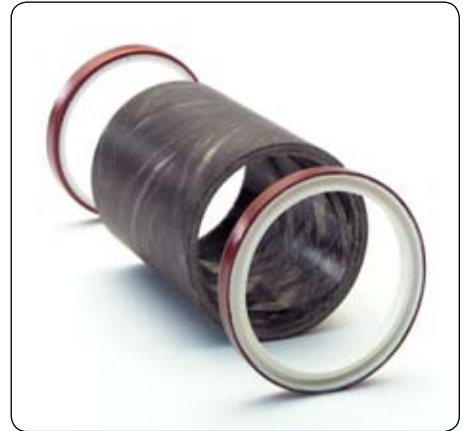
Filament wound bushings with matching seals
