Customer reference case

SKF filament wound bushings

Filament wound bushings increase MTBF for Herder

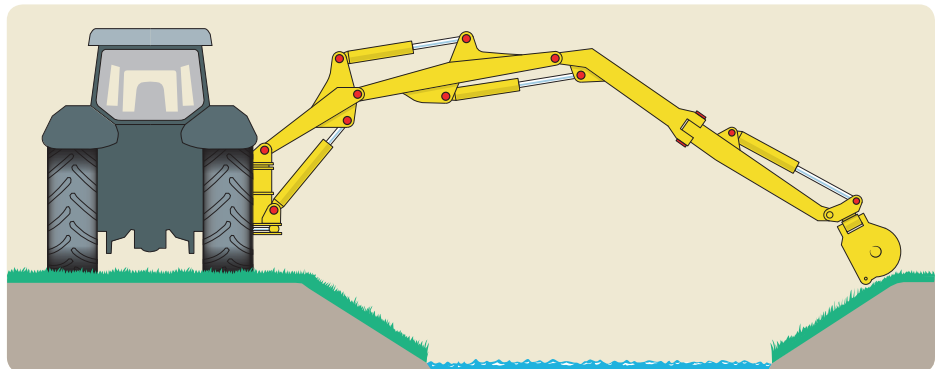
Sketch of boom with different bearing locations indicated

After a thorough examination of the application, SKF application engineers recommended SKF filament wound bushings. Their research showed that filament wound bushings would accommodate the operating conditions for all but 3 locations. In all other cases, however, SKF engineers felt that SKF filament wound bushings would meet the customer's first objective to provide a maintenance-free solution and that the bushings would also increase MTBF of the cylinder ends.

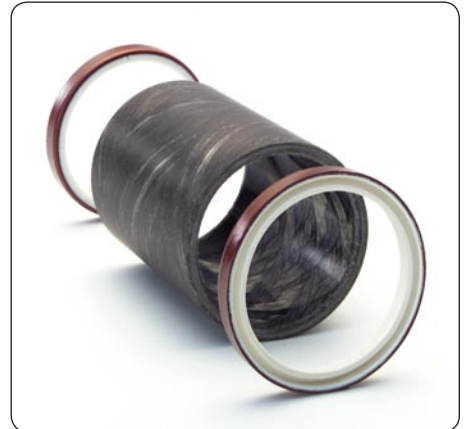
Filament wound bushings with matching seals
