Monitoring slow rotating equipment with vibration analysis?

Low speed bearing monitoring – Challenges and solutions

Low speed bearing monitoring

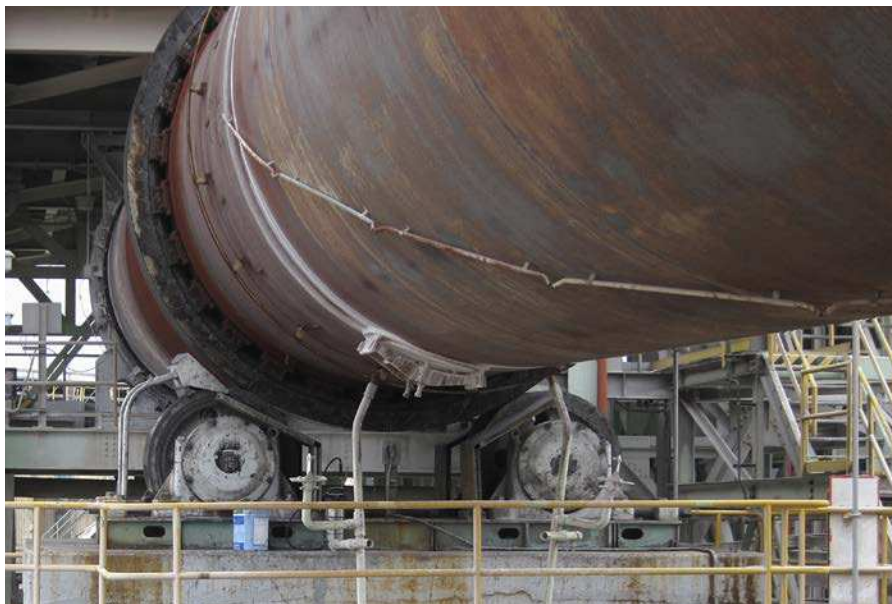
Fig. 3: Lime kiln support rollers

To illustrate the effectiveness of our low speed monitoring techniques, let us consider the example of a kiln support roller bearing turning at around 6 r/min (→ fig. 3). The key measurement specifications were as follows:

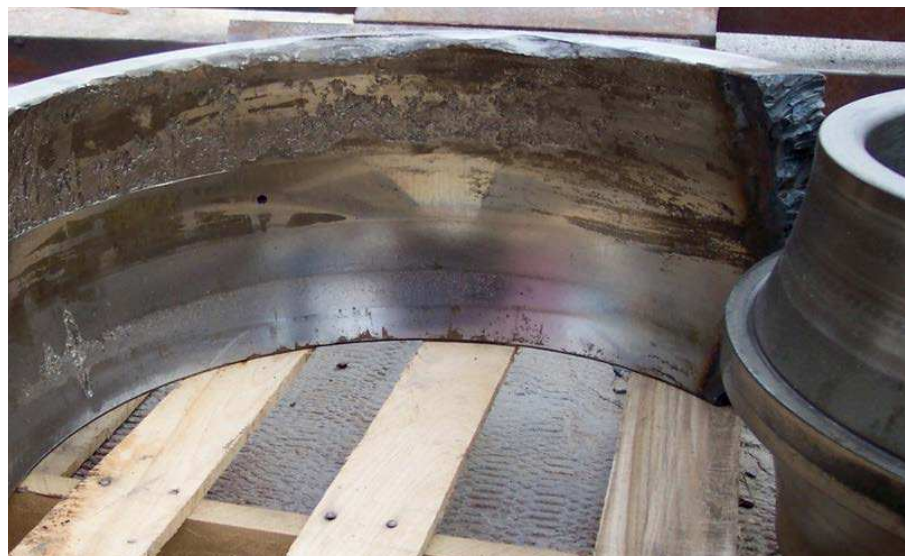
Fig. 7: Severely damaged bearing outer race

At this point the damage had grown quite significantly and the bearing needed to be replaced soon. The time waveform display taken just before the bearing was replaced in October (→ **fig. 6**) shows multiple roller impacts on the raceways indicating severe damage. This was verified when the bearing was replaced (→ **fig. 7**). As can be seen from the damage pattern, the bearing was subjected to large axial forces.

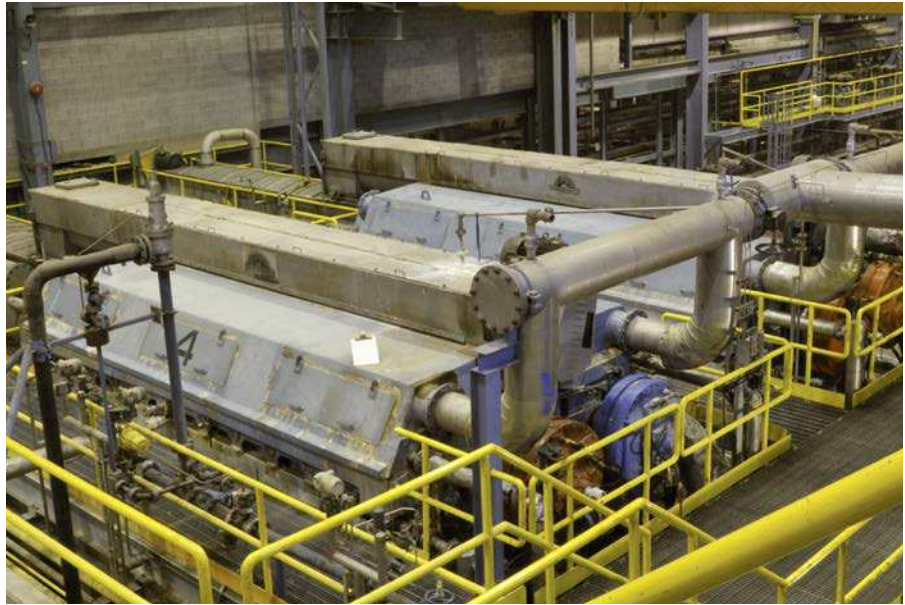
Fig. 8: Twin roll press

The situation changes, however, in cases where the rotational speed is not steady. A good example of this is a twin roll press which typically runs from about 6 to 12 r/min (→ fig. 8).

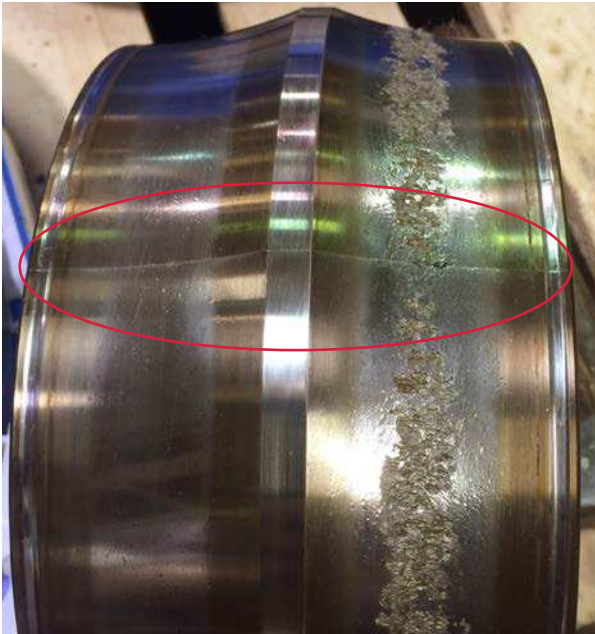
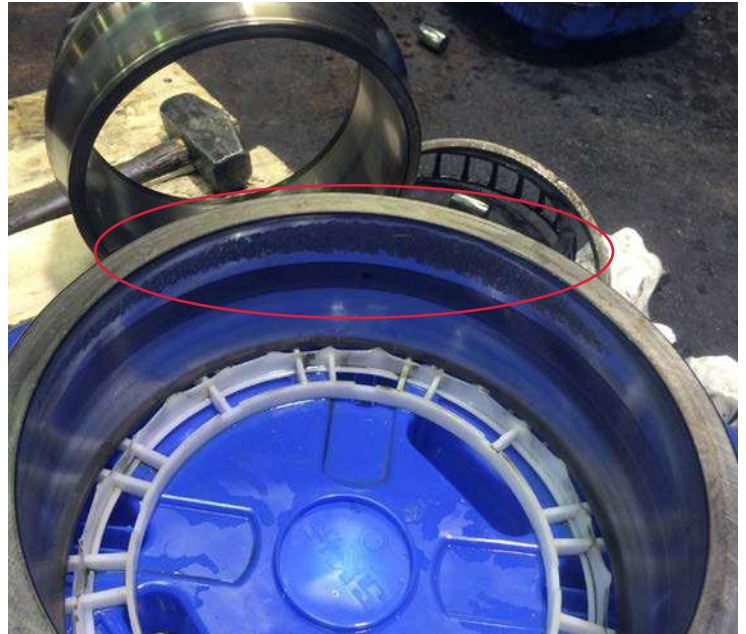
Fig. 16: Damaged bearing inner and outer rings

Fig. 16 shows the bearing after it was dismounted and cleaned for root cause failure analysis. Both the inner ring crack as well as damage from one side/roller set are clearly visible. The latter indicates the possibility of overloading in the axial direction or wear from contamination or insufficient lubrication.
