Idled machines still need maintenance

Restarting production after a long stop can be costly if you don't do it right

SKF Global Pulp & Paper Segment

PUB 72/S9 11147/9 EN · February 2014

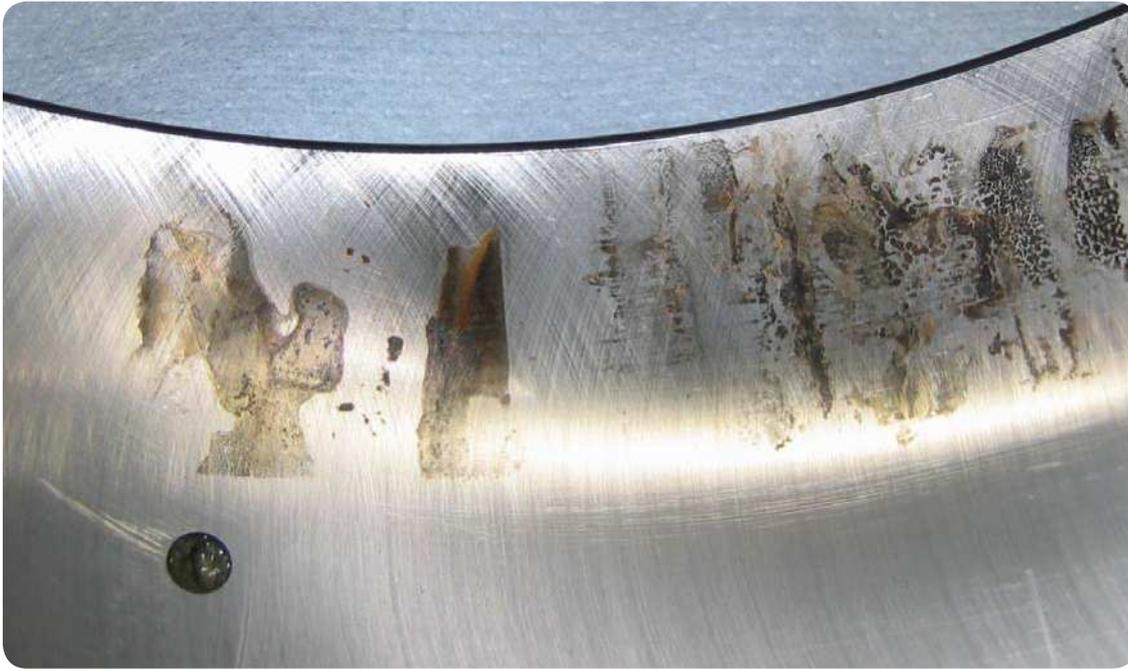
Standstill corrosion on a bearing due to process water contaminated grease.

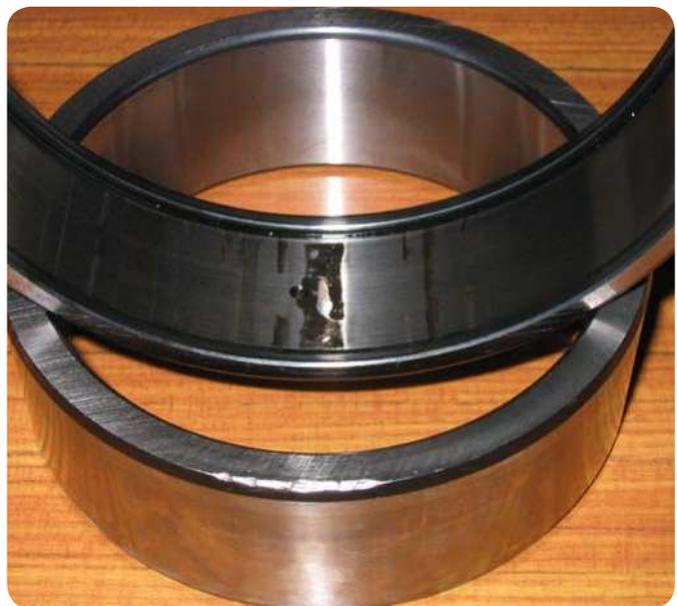
Fig. 2 Standstill corrosion in a needle roller bearing from a tissue converting plant. The machine it was mounted on had been cleaned with high pressure water.

The number one cause of bearing damage during prolonged stops in the paper industry is standstill corrosion. This is hardly surprising given the humid environment, the use of high-pressure cleaning, condensation forming in bearings and housings as they cool down and because bearings are predominantly made of steel and are therefore very sensitive to corrosion. Bearings are especially at risk during stops because water or process fluids easily separate from the lubricant (see **figure 1**) and cause damage (see **figures 2 and 3**)

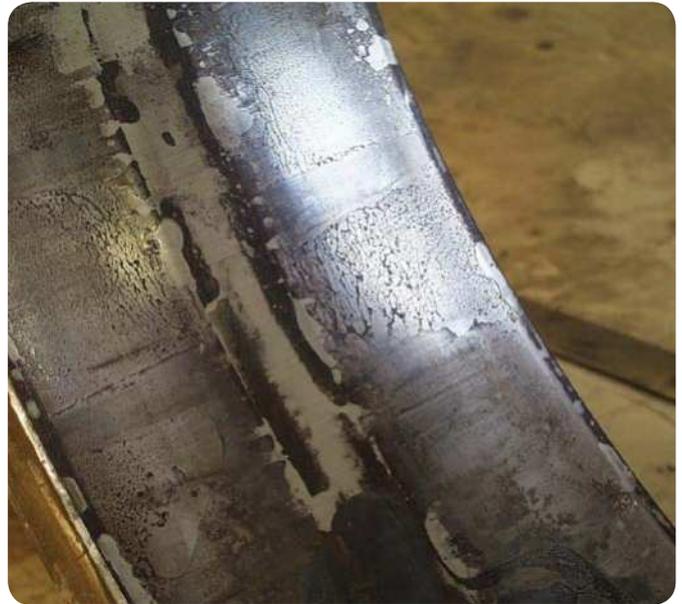
Fig. 3 The outer ring of a spherical roller bearing that was mounted on a paper machine.

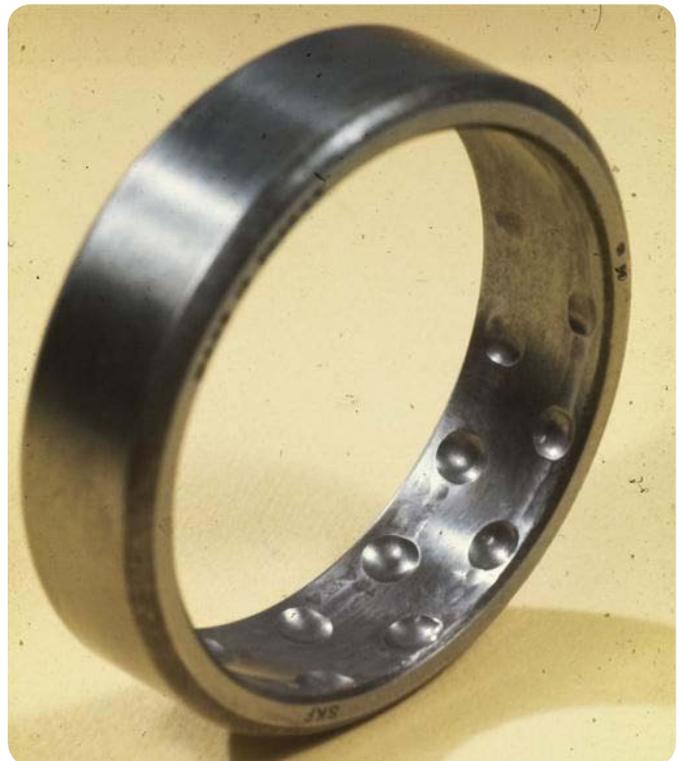
Fig. 4 An outer ring of a self-aligning ball bearing that has been subjected to false brinelling.

The number two cause of damage is false brinelling. This is caused by vibration in the direct surroundings of a bearing that is not rotating. Due to this vibration, the rolling elements of the bearing are subject to micro-movements that free microparticles from the bearing raceways which corrode and act as an abrasive. The result is marks that look like indentations caused by pushing the rolling elements into the raceways, but with no burrs or displaced material (see **figure 4**).

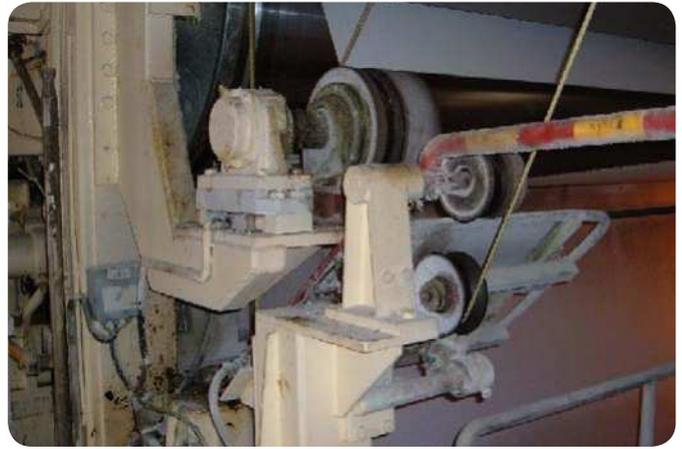
Fig. 7 Dust collects on shafts and hubs.

In the dryer section, the conditions are more difficult. It's hotter with an average ambient temperature of 100 °C and there's a lot of dust. For every 15 °C over 70 °C, the relubrication interval needs to be halved. This means relubricating the sheaves in the dryer section every six months instead of every 27 months. The dust causes its own problems. It collects on the shaft and the hub (see figure 7) and can act as a wick that drains the oil out of the grease.

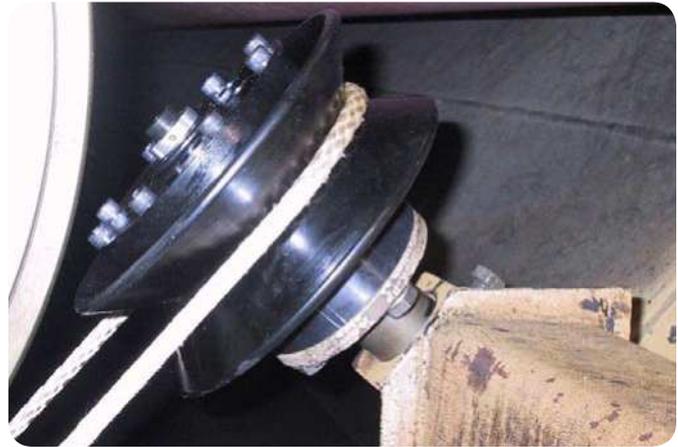
Fig. 8 The SKF rope sheave unit in operation.

Tests were successfully completed in the same year and Stora Enso immediately replaced 68 sheaves with the new SKF rope sheave units (see **figure 8**). The new units run for four years before there is any need for inspection (Note that this is in the dryer section of a fast machine and that with more favourable conditions longer service lives have been achieved). If necessary, they can be refurbished with replacement bearings, grease and seals. The other parts can be reused which, over time, leads to substantial cost savings.

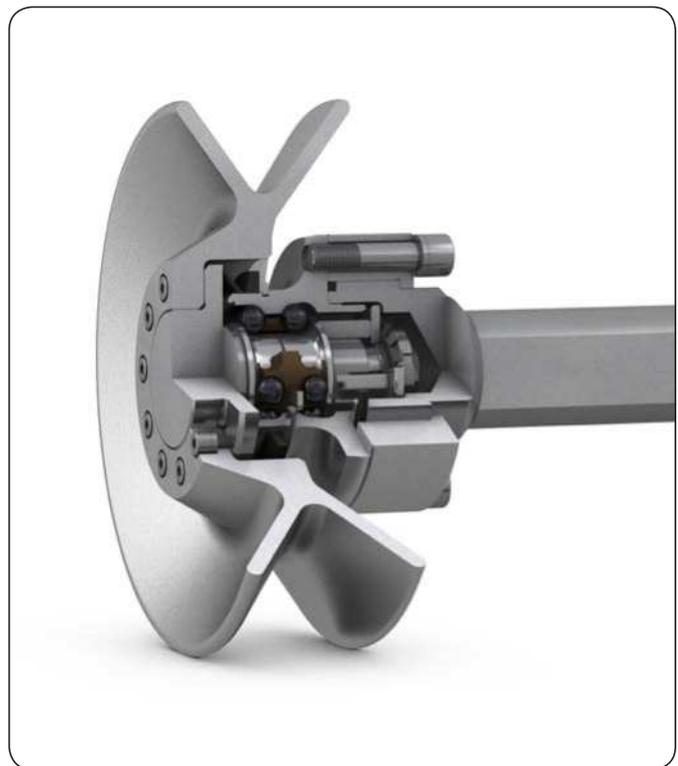
Fig. 9 New generation SKF rope sheave unit.

Following the success of the original SKF rope sheave units, a second generation unit was developed with improved sealing and a lower price. In addition, it was possible to reduce the sheave core diameter from the 150 mm of the original design to 110 mm on the new one (see **figures 9** and **10**).

The basis of the design is an SKF car hub unit. After all, if they can withstand water, mud, salt, heat, cold, high pressure cleaning, high rotational speeds, high axial forces and shock loads, why not use them as the basis for rope sheaves on paper machines? Some modifications were made, of course. The metal balls were replaced with ceramic ones and the high performance grease used in the original design was selected.

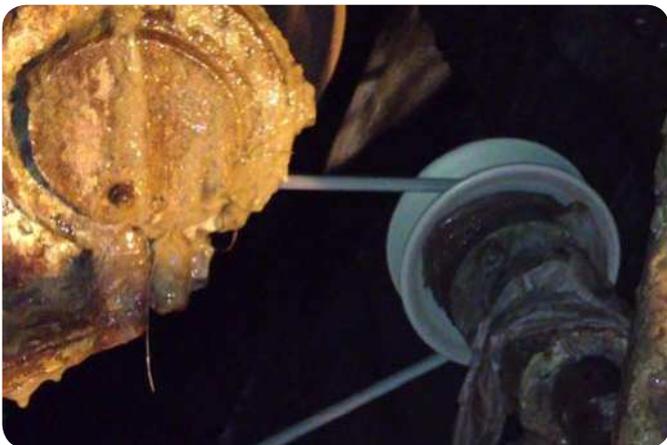
Fig. 10 New generation SKF rope sheave unit in operation.

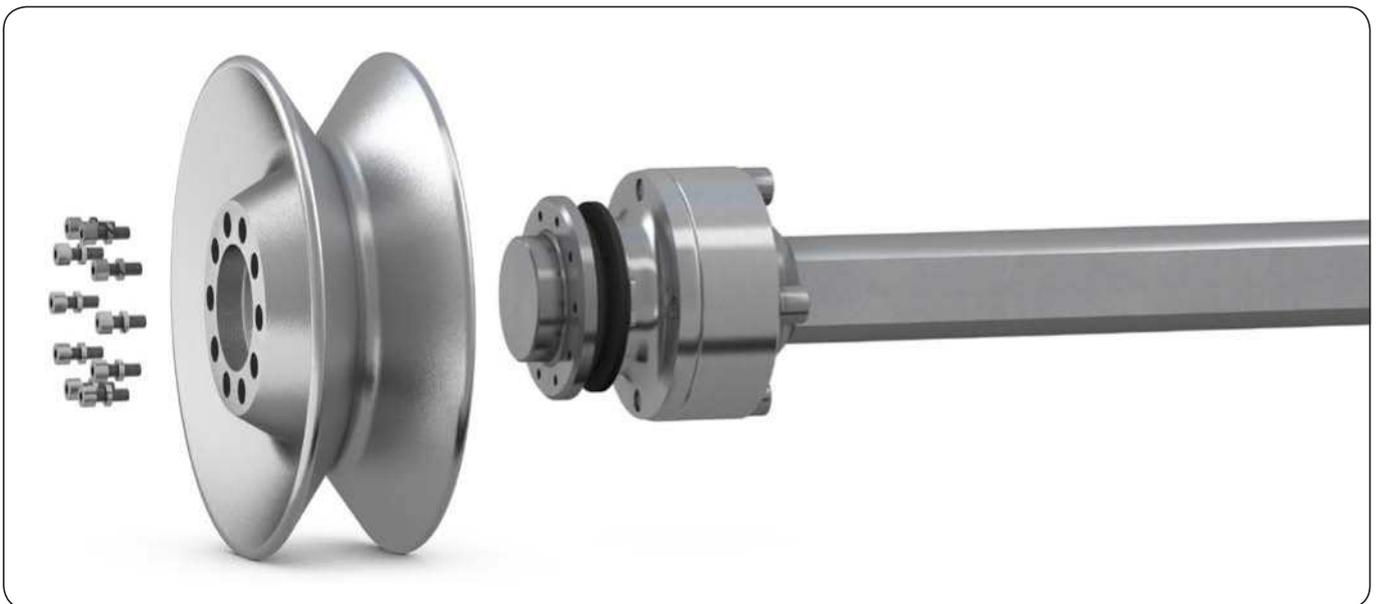
Fig. 12 The sheave and shaft can be used again.

If, after many years of trouble-free operation, the unit needs to be replaced, the sheave and shaft can be reused (see **figure 12**). Only the bearing hub unit needs to be replaced, which is supplied fully assembled and ready to be used.
