VKM 15216 - VKPC 85624

Technical Bulletin – March 2012

CHEVROLET, DAEWOO, OPEL, SAAB, VAUXHALL

T0139

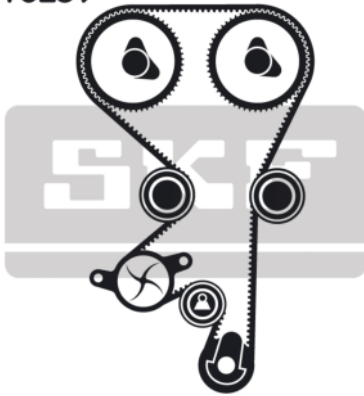
The correct fitting of the VKM 15216 tensioner is very critical and the SKF fitting instructions contained in the SKF Timing belt kits must be followed (see last page for kits concerned by this technical bulletin).

The tightening torque of the tensioner bolt (supplied with the tensioner) must be strictly adhered to – If the fitting instructions are not followed correctly, the tensioner back plate, the bolt or the water pump could be damaged or in severe cases even break.

Over-tensioning the belt system will cause failure of the water pump first - as this component is the most affected by incorrect fitting.

One sign of overtension is an audible noise coming from the water pump, quite often experienced after only a few kilometers of operation.
