Visual inspection of bearing can establish probable cause of damage

Drying cylinder bearing damage: case 1

PUB 11147/26 EN · August 2019

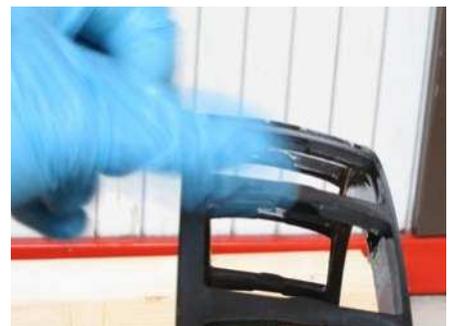
The very first action is to check whether the half cages have signs of wear – in the drying cylinder application, this would point to a lubrication issue. Visual inspection shows very slight abrasive wear in the cage pockets where there is contact with the rollers (→ **fig 15, 16 and 17**). I cannot feel any sharp edges with my thumb (→ **fig 17**), and there is only slight abrasive wear on one half cage – at the contact with the guide ring (→ **fig 16**), and, on the other guide ring, at the contact with the inner ring (→ **fig 15**). Note that sharp edges and/or burrs are created by a lack of lubrication between the roller and the cage. Of course, there is a risk that you could cut yourself, so you must be as careful as when checking the sharpness of a knife with your finger. Unfortunately, the touch-test is often more effective than the visual inspection. There is no adhesive wear (smearing).

Fig. 17: Feeling for sharp edges or/and burrs with the thumb.

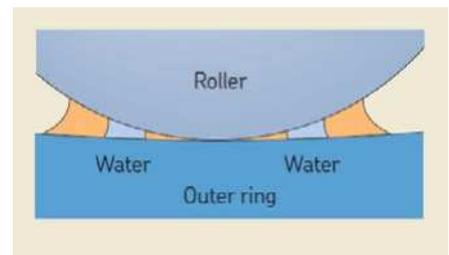
"If a non-rotating bearing has free water in the lubricant, this water will accumulate at the bottom of the bearing. The concentration of the water will be highest at a certain distance from the rolling contact (→ fig 31). The reason for this is that the free water in the oil, being heavier, will sink until it comes to a suitable gap between the roller and the raceway. Corrosion due to water or any other aggressive liquid at, and, around the contact surface between rollers and raceways is called contact corrosion, standstill corrosion or etching.

Fig. 31: Water concentration in a stationary bearing.
