## Pacific Gas and Electric Corp. troubleshoots mechanical issue using dynamic motor analyzer

### SKF's portable EXP4000 finds root causes of problems with a critical motor at Diablo Canyon Power Plant

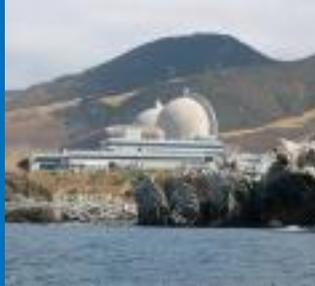
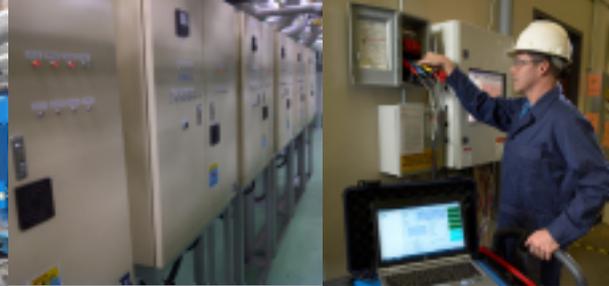
One of the PG&E electricians dealing with the problem decided to gather more information about the motor/machine system before advocating motor replacement. Using an SKF EXP4000 dynamic motor analyzer, the electrician was able to assess torque behavior against the rated torque of the motor. The torque signature displayed by the EXP4000 clearly indicated the 125 hp motor was operating in an overloaded condition.

undergone an impeller replacement just a few months earlier. Closer review showed that the installed replacement impeller was actually larger than the impeller it replaced (17 in v. 15.75 in).

**The EXP4000's phasor analysis of the pump motor.** Normal torque (left) compared to torque overload condition (right).

The pump underwent scheduled downtime, and the oversized impeller was replaced with the correct part. Once up and running, the motor was tested again. Torque values were properly aligned with rated torque for the motor, and there were no longer any excessive heat or overcurrent issues with the motor.
