Replacement of the CV-joint VKJA 5342

This bulletin describes the replacement guidelines of a CV-joint on a Renault Laguna I 1.8. It also highlights the CV-joint locking system used in this type of CV-joint design.

CV-Joint replacement guidelines for Renault Laguna

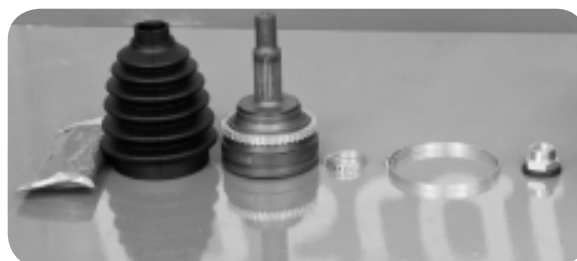
Picture 1: VKJA 5342 kit containing a pre-greased CV-joint with pre-installed snap-ring, boot, short and long clamps, grease bag and wheel nut.

The VKJA 5342 kit supplied by SKF contains all of the components needed for the repair (see picture 1). This, coupled with the step-by-step replacement guidelines on the following pages – you can be sure that you will carry out a trouble free CV-joint replacement and that you will save money for the car owner and make more profit for your business.

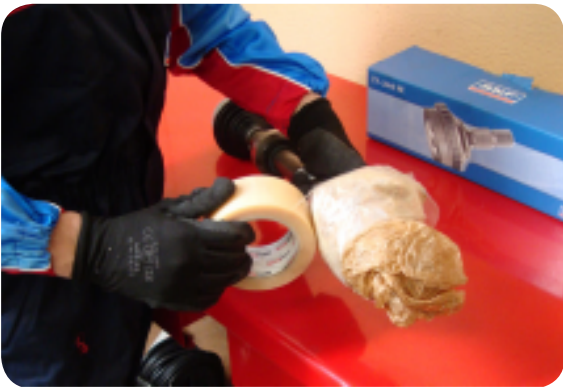
1. Remove the driveshaft in accordance with the vehicle manufacturer's workshop manual.
Tip: Add protection to the CV-joint on the gearbox side to prevent the CV-joint from sliding off the shaft.

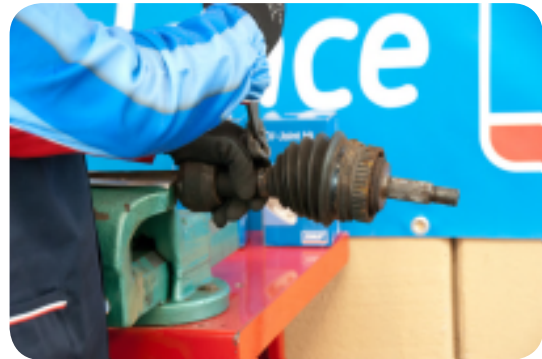
3. Remove both the inner and outer clips. Then, cut the boot and remove it.

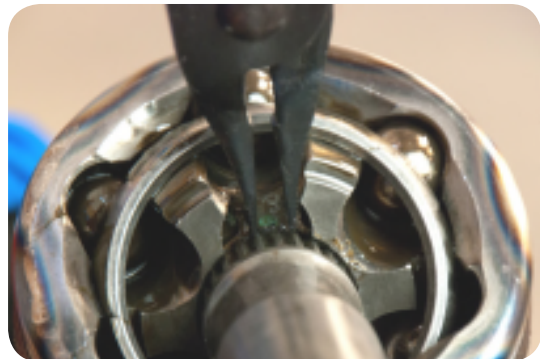
4. In order to clearly see the snap ring, remove the grease from around the base of the shaft. Then with suitable pliers, hold the snap ring open. The CV-joint is then ready to be removed from the shaft.

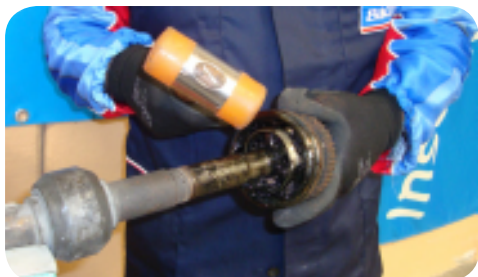
5. Hold the CV-joint and pull it off the shaft. Lightly tapping with a hammer may help.

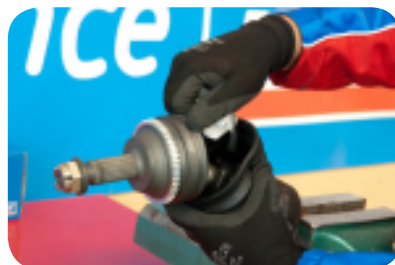
3. Slide the boot into position ready for mounting and fill with all of the supplied grease.

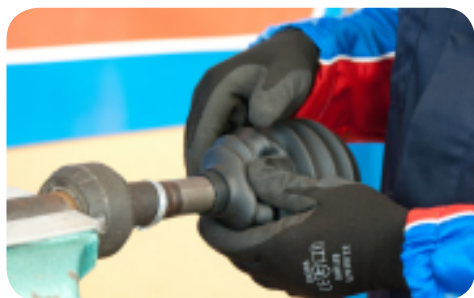
1. Put the short boot clamp on to the shaft first and then slide the boot on to the shaft.

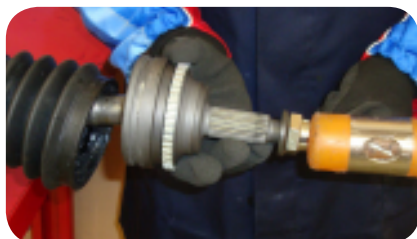
2. Locate the CV-joint on to the spline on the end of the shaft, then tap the

CV-joint on the shaft with a plastic hammer, until the snap ring locks into its groove in the inner race. Make sure that the CV-joint is locked onto the shaft correctly by moving the joint back and forth, to ensure the snap ring is correctly engaged in the retaining groove.

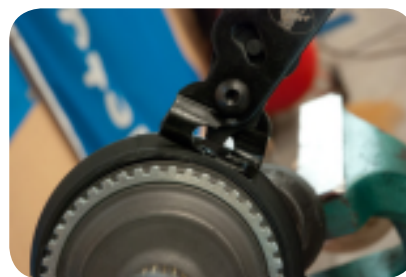
4. Fit the short clamp onto the boot and tighten it with a suitable tool, then pull the boot onto the CV-joint locating it into the correct position on the bell. Fit the long clamp and tighten it with the same tool. The clamp

tightening operation must be performed by using special pliers with an integrated hold-down device; this prevents the unintentional opening of the clamps after tightening.
