VKJA 3525

Technical Bulletin – April 2011

Technical Information: VKJA 3525 Replacement guidelines

This bulletin describes the replacement guidelines of a wheel side CV-Joint on a Toyota AYGO 1.0, Citroen C1 1.0 and Peugeot 107 1.0.

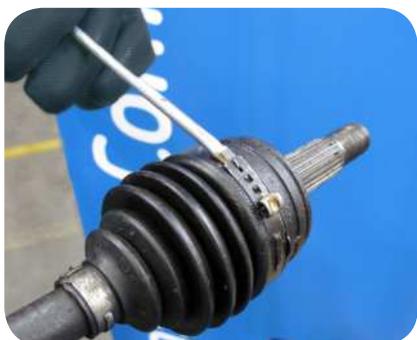
2. Place the driveshaft in a vice (with aluminum or protective jaws).
Remove both the inner and the outer clips.
Cut the boot and remove it.

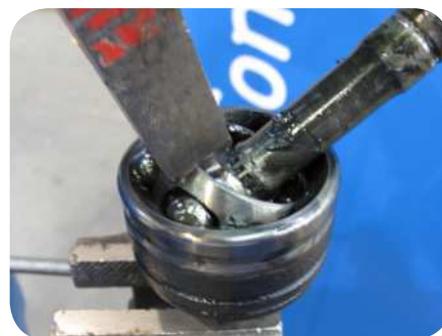
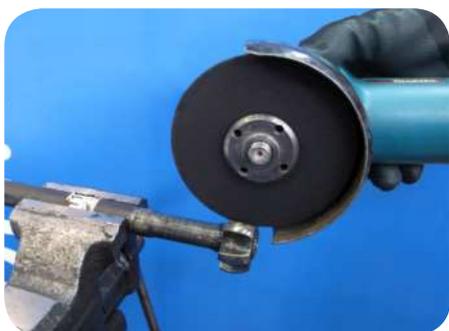
3. Place the CV-Joint bell in the vice.
Then break the cage, in several positions along the edge (close to the balls) using a hammer and chisel.

4. Cut the tracks of the inner race, in 2 or 3 positions by using a suitable cutting tool.

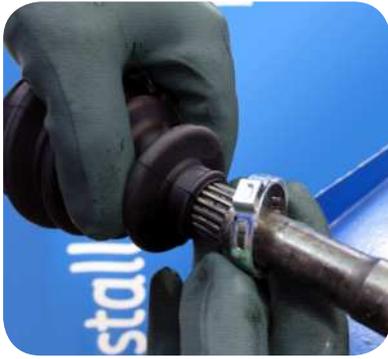
1. Put the short boot clamp on the shaft.
Slide the boot on the shaft.

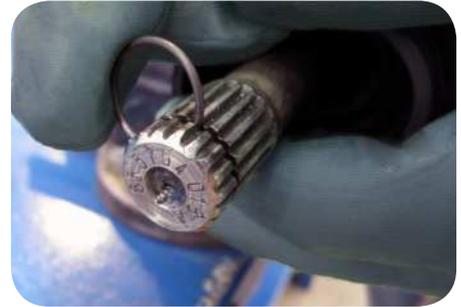
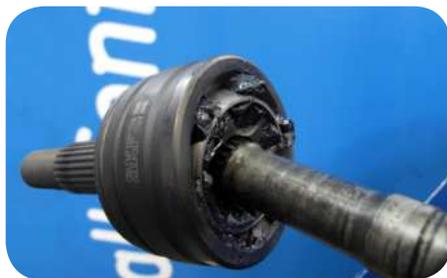
2. Fix the new circlip into the groove.

3. Press the new CV-Joint onto the shaft.
Tap with a rubber hammer until the circlip locks into its groove in the inner race of the CV-Joint.

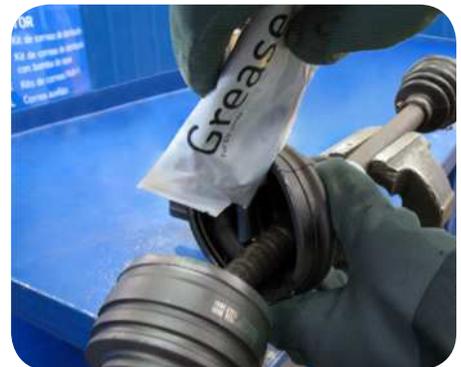
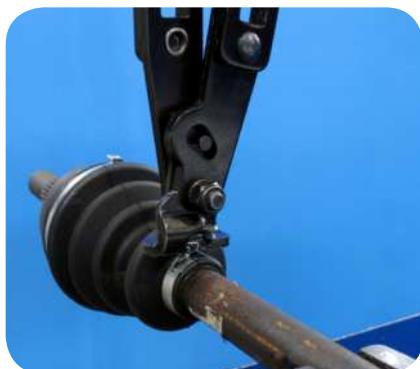
4. Slide the boot into position ready for mounting and fill with all of the supplied grease.

5. Fit the short and long clamps onto the CV-Joint boot and tighten them with a suitable tool.
