Premature bearing failures in wind turbine gear units

Drivers and counter measures

SKF Wind Farm Management Conference, 2016

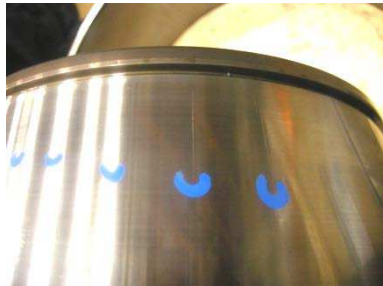
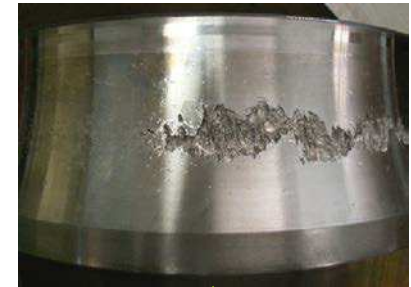
Crack appearance depending on heat treatment

Through hardened as well as case carburized can fail!

Martensite
+50 to +100 MPa
Tensile at surface

Bainite
-50 to -100 MPa
Compressive at surface

Through hardened

Case carburized
-100 to -200 MPa
Compressive at surface

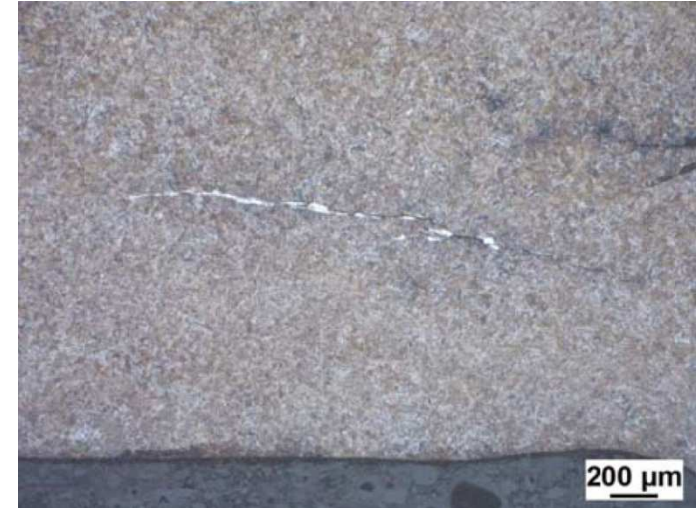
White etching areas are created around cracks due to crack face rubbing

White etching crack in large TRB rolling contact fatigue test
