# VKM 22380 / VKM 22385

Technical Bulletin - April 2009

SOFIM Engine: Mounting recommendations

How to avoid incorrect torque and failures during installation

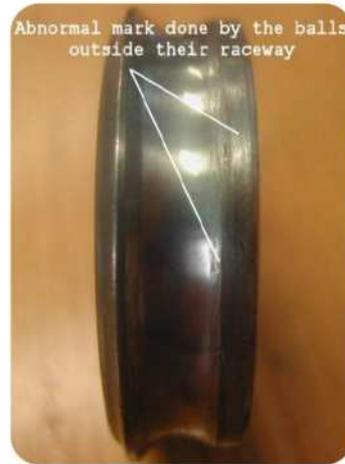
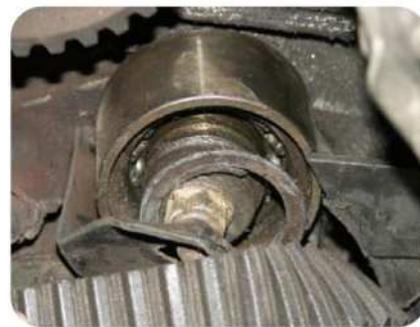
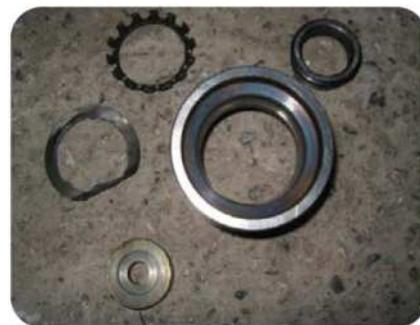
- The engine vibrations and the belt load will lead to the complete unscrewing of the bolts/nuts. This will end up in the disassembling of the inner ring and therefore the bearing failure.
- In this case, the seal has come out of the bearing and the ball cage with the balls have been ejected.

- Always apply the tightening torques as recommended by the OE vehicle manufacturer - this determines the preload of the bearing!
