# SKF extends service life of bearings in textile processing machine by more than 3 times

PUB BU/S6 16033 EN · October 2015

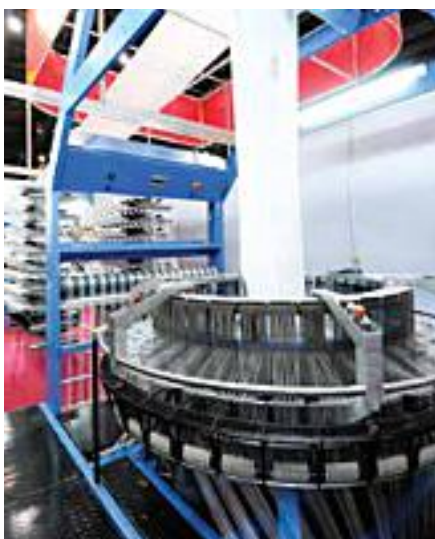
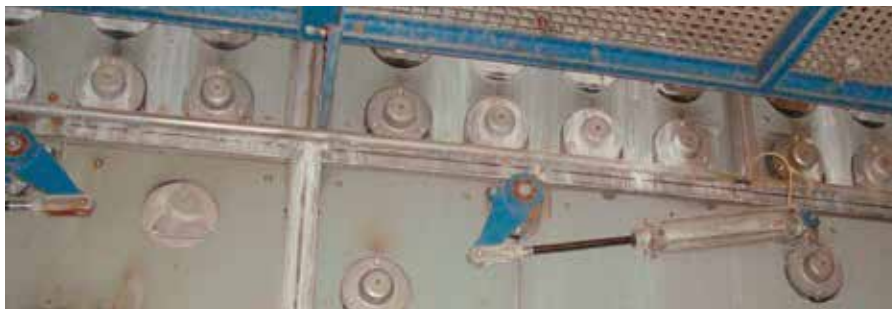
- Handles up to 1.5 degrees of misalignment
- Steel cage for increased heat and chemical resistance
- Sheet steel-reinforced NBR seal
- Bearing internal radial clearance increased to C4
- High-temperature grease with higher grease fill

- Textile PTR machine: guide roller bearings in washer tanks/steamer chambers
- Speed: 70 m/min
- Operating temperature: 105 °C
- Inner ring rotation

SKF engineers next went about optimizing the basic bearing design to meet Nahar's requirements. They replaced the polymer cage with a steel cage to withstand caustic chemicals and high temperatures. They increased internal clearance to better handle misalignment and abnormal temperature spikes. They also chose a high-performance, steel-reinforced NBR seal to eliminate bulging and leakage, and used a long-life, high-temperature grease with improved water resistance in a higher grease fill volume.
