Power Plant Avoids Cost of Motor Replacement

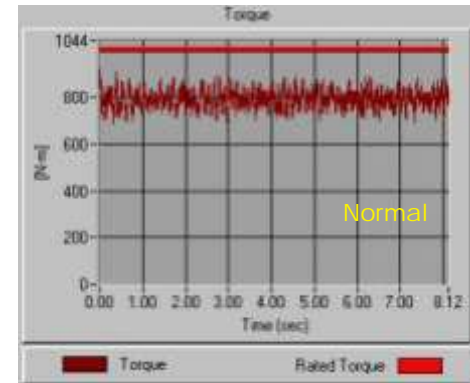
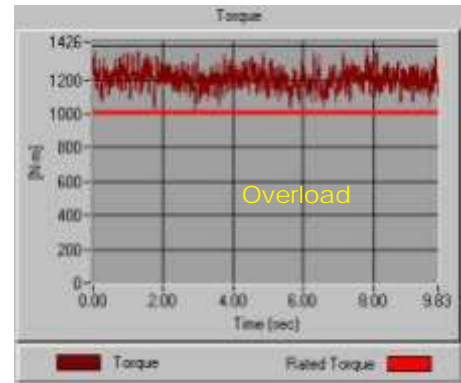
Explorer Diagnoses Condition

The load profile showed higher than rated values. Maintenance history research revealed that the impeller had been replaced in October 2004. It was discovered that a 17 inch impellor had been installed instead of the required 15.75 inch impellor. A properly sized impellor was installed, lowering the amperage to the expected values.

The Explorer testing played a major role in ruling out a motor problem and going after the pump. Without the Explorer data it would have been likely that the motor would have been replaced at a cost of over \$23,000, and the condition would have continued to exist.
