# Restarting production after a long stop can be costly if you don't do it right

# Small things can matter

PUB 72/S9 11147/9 EN - February 2014

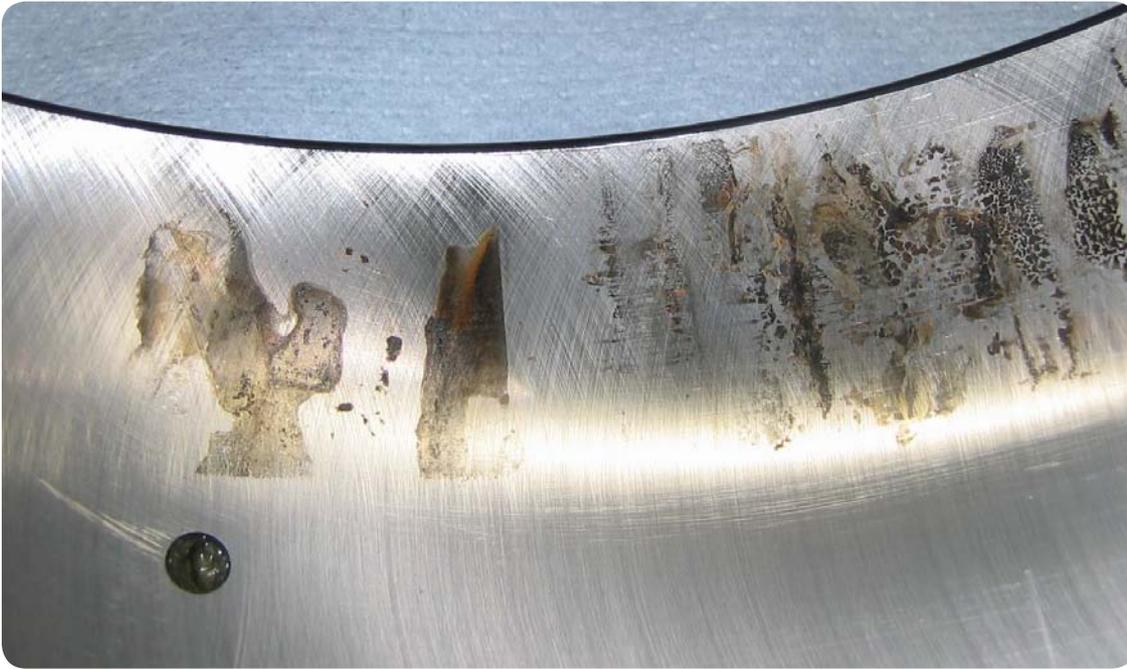
*Standstill corrosion on a bearing due to process water contaminated grease.*

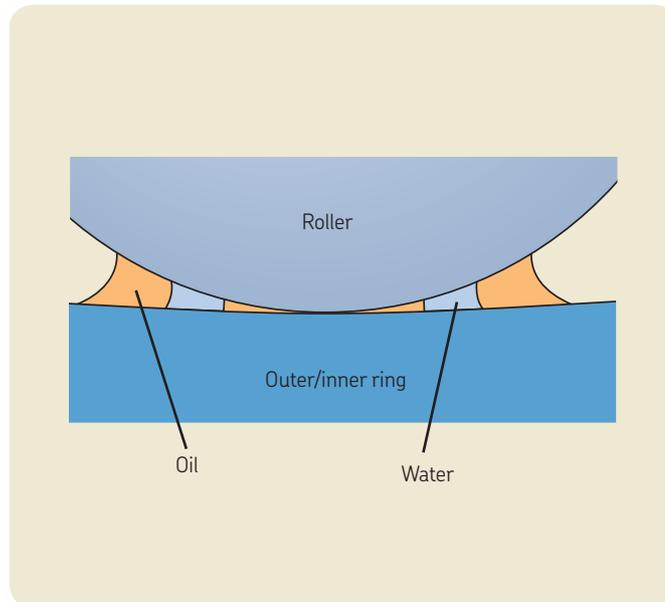
Fig. 1 Water or process fluids can easily separate from the lubricant.

The number one cause of bearing damage during prolonged stops in the paper industry is standstill corrosion. This is hardly surprising given the humid environment, the use of high-pressure cleaning, condensation forming in bearings and housings as they cool down and because bearings are predominantly made of steel and are therefore very sensitive to corrosion. Bearings are especially at risk during stops because water or process fluids easily separate from the lubricant (see **figure 1**) and cause damage (see **figures 2 and 3**)

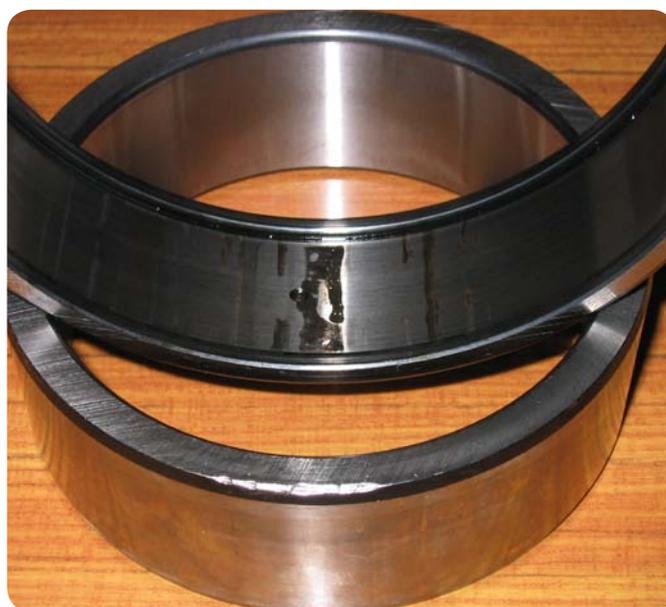
Fig. 2 Standstill corrosion in a needle roller bearing from a tissue converting plant. The machine it was mounted on had been cleaned with high pressure water.

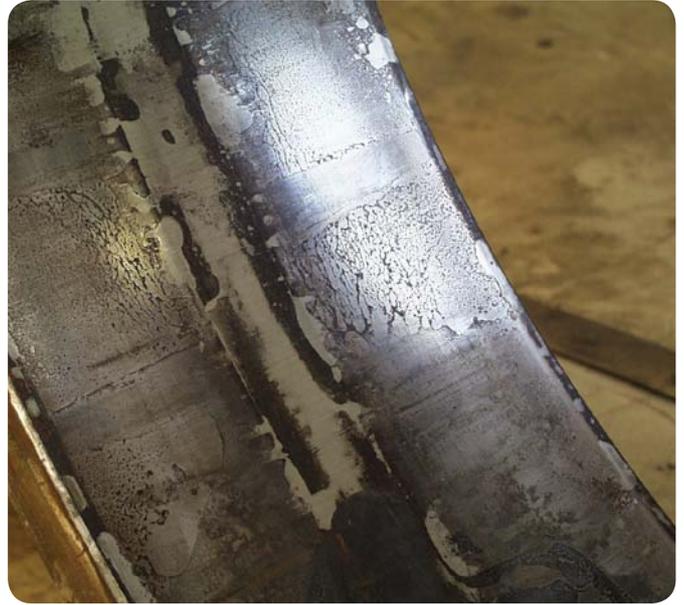
*Fig. 3 The outer ring of a spherical roller bearing that was mounted on a paper machine.*

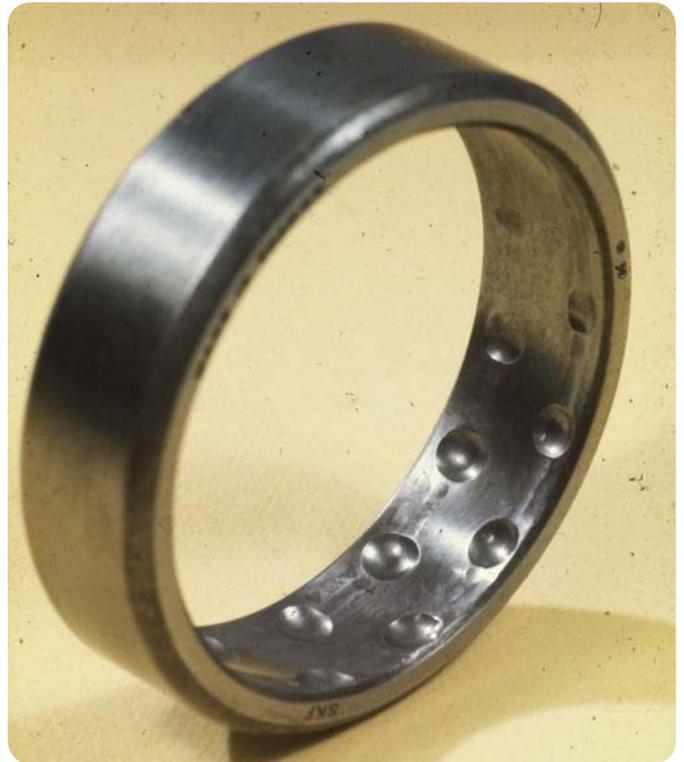
*Fig. 4 An outer ring of a self-aligning ball bearing that has been subjected to false brinelling.*

The number two cause of damage is false brinelling. This is caused by vibration in the direct surroundings of a bearing that is not rotating. Due to this vibration, the rolling elements of the bearing are subject to micro-movements that free microparticles from the bearing raceways which corrode and act as an abrasive. The result is marks that look like indentations caused by pushing the rolling elements into the raceways, but with no burrs or displaced material (see **figure 4**).

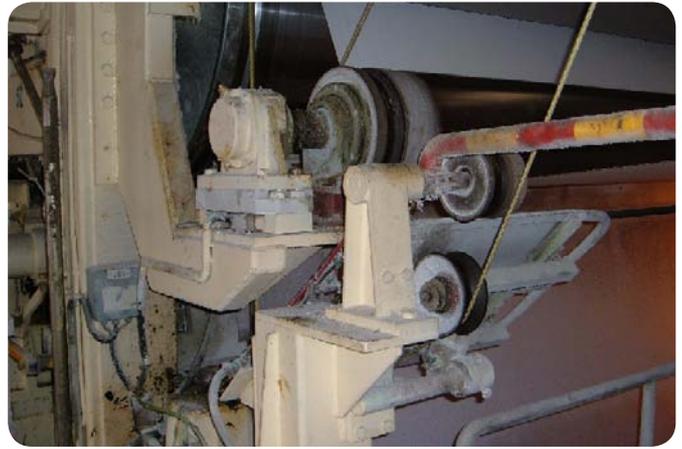
*Fig. 7 Dust collects on shafts and hubs.*

In the dryer section, the conditions are more difficult. It's hotter with an average ambient temperature of 100 °C and there's a lot of dust. For every 15 °C over 70 °C, the relubrication interval needs to be halved. This means relubricating the sheaves in the dryer section every six months instead of every 27 months. The dust causes its own problems. It collects on the shaft and the hub (see figure 7) and can act as a wick that drains the oil out of the grease.

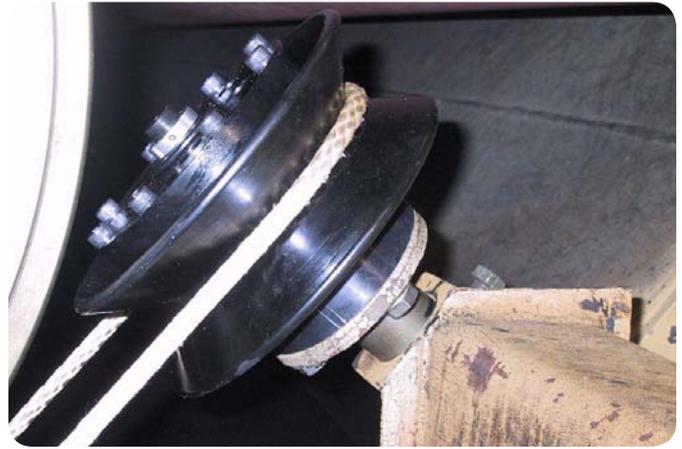
*Fig. 8 The SKF rope sheave unit in operation.*

Tests were successfully completed in the same year and Stora Enso immediately replaced 68 sheaves with the new SKF rope sheave units (see **figure 8**). The new units run for four years before there is any need for inspection (Note that this is in the dryer section of a fast machine and that with more favourable conditions longer service lives have been achieved). If necessary, they can be refurbished with replacement bearings, grease and seals. The other parts can be reused which, over time, leads to substantial cost savings.

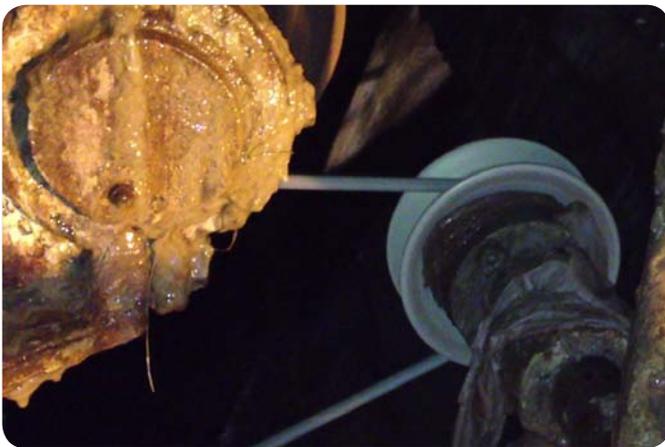
*Fig. 10 New generation SKF rope sheave unit in operation.*

Following the success of the original SKF rope sheave units, a second generation unit was developed with improved sealing and a lower price. In addition, it was possible to reduce the sheave core diameter from the 150 mm of the original design to 110 mm on the new one (see **figures 9** and **10**).

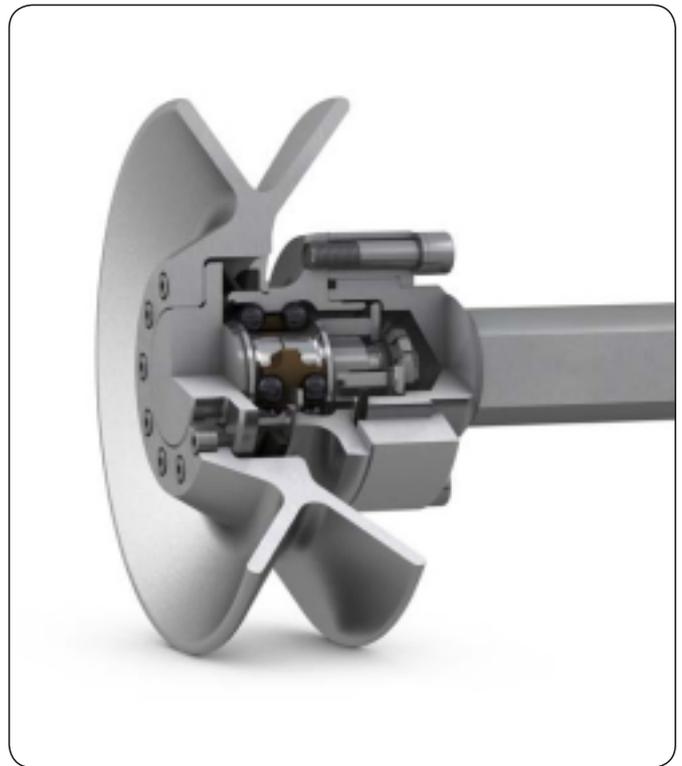
*Fig. 9 New generation SKF rope sheave unit.*

The basis of the design is an SKF car hub unit. After all, if they can withstand water, mud, salt, heat, cold, high pressure cleaning, high rotational speeds, high axial forces and shock loads, why not use them as the basis for rope sheaves on paper machines? Some modifications were made, of course. The metal balls were replaced with ceramic ones and the high performance grease used in the original design was selected.

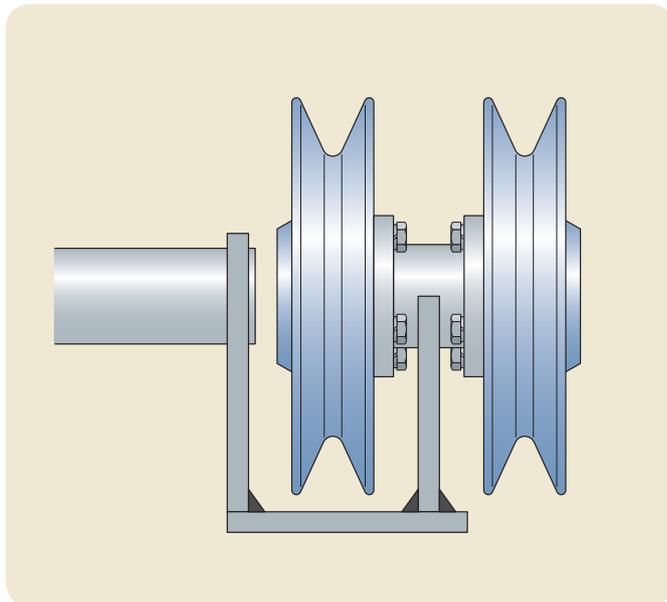
*Fig. 11 A double independent unit.*

Due to the design, units with two or more independently running sheaves are now possible (see **figure 11**). This creates a wide range of application possibilities for the paper industry.

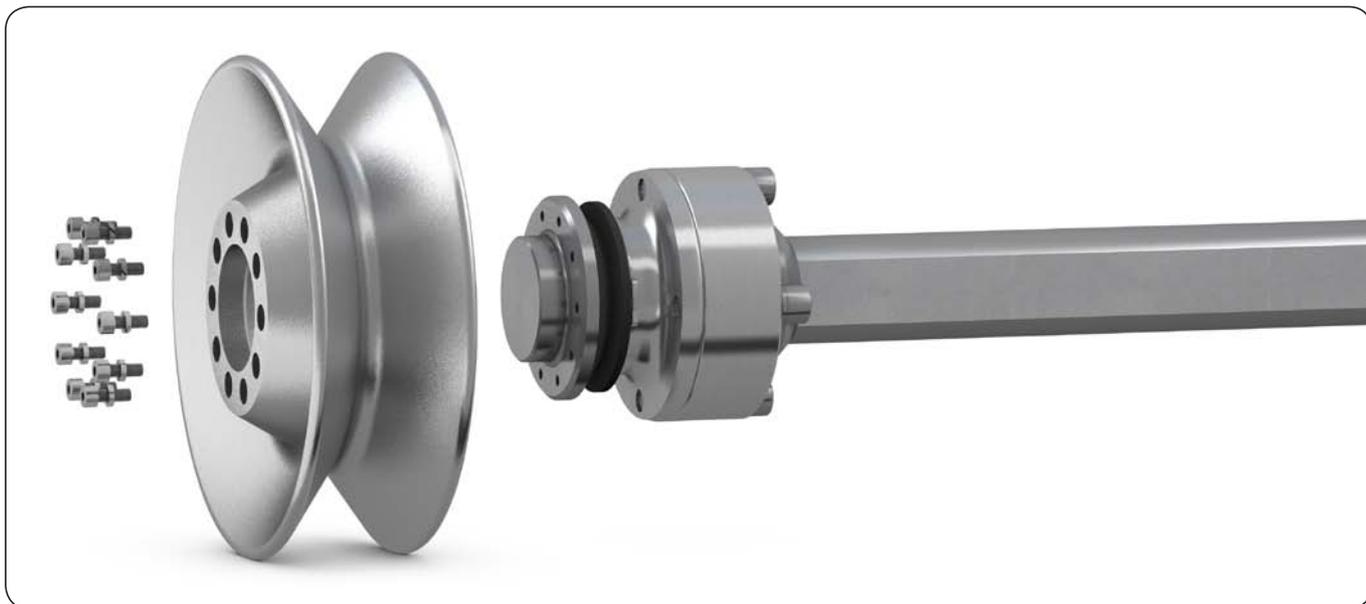
*Fig. 12 The sheave and shaft can be used again.*

If, after many years of trouble-free operation, the unit needs to be replaced, the sheave and shaft can be reused (see **figure 12**). Only the bearing hub unit needs to be replaced, which is supplied fully assembled and ready to be used.
