## Spare a little thought for your fans?

# The importance of proper support for your fans

# Issues with oversized bearings and a quick solution

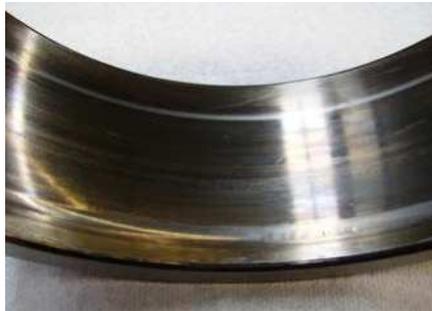
*Fig. 1: Path pattern on an outer ring raceway*

All the self-aligning ball bearings that I inspected had a wide path pattern on the whole circumference of the inner and outer ring raceways, cage wear - and sometimes breakage - and fretting corrosion on the outside of the outer ring (see **figures 1-4**)

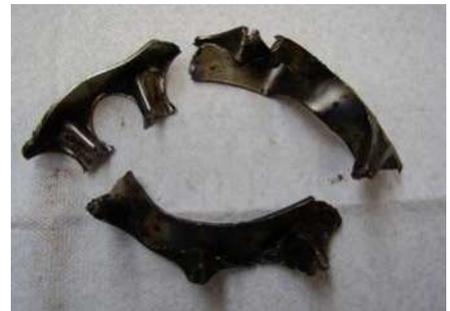
*Fig. 3: Broken cage*

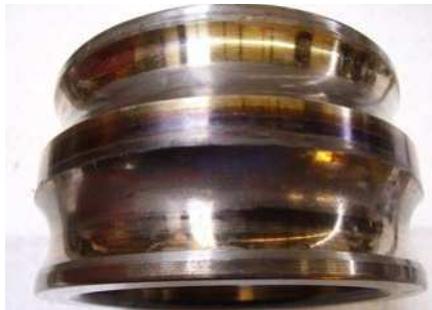
*Fig. 2: Path pattern on inner ring raceways*

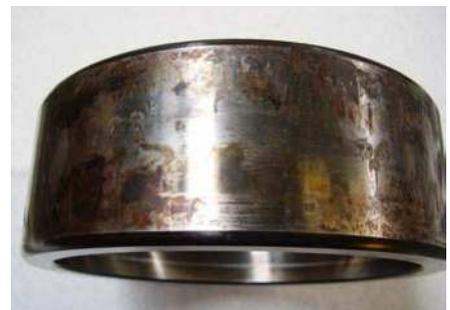
*Fig. 4: Fretting corrosion on an outer ring*

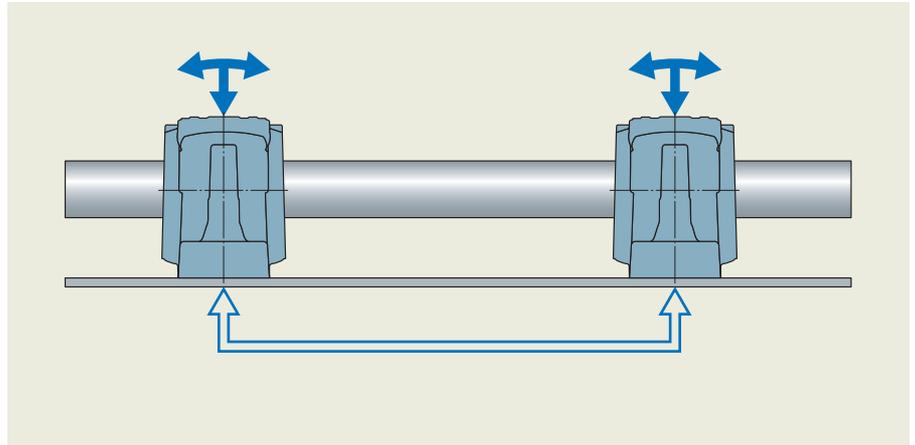
*Fig. 5: The pendulum motion of inadequately supported housings*

and had measured vibration on their plummer blocks and the supports. They told me that vibration analysis had shown them that their plummer block housings were moving in an axial direction, in a pendulum motion, with a certain frequency (see **fig. 5**)

When a plummer block housing moves like this, the outer ring of the bearing in it makes the same movement relative to the balls and inner ring. When this happens with a certain frequency, the balls move in both a radial and an axial direction over the raceways. This creates a kinematic disturbance in the rolling contact between ball and raceway leading to surface distress when the lubrication film collapses.

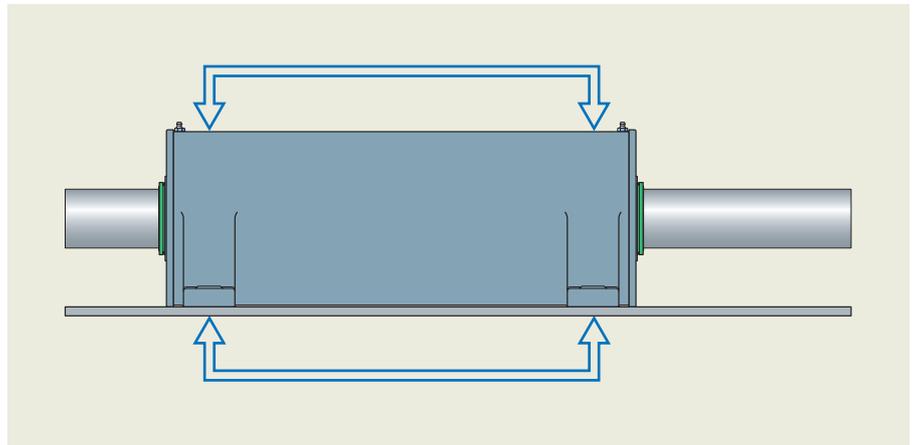
*Fig. 6: Support in a PDN two bearing housing*

By mounting a single PDN two bearing housing instead of two separate plummer block housings the bearing arrangement is more rigid and the bearings will not experience the pendulum movement. The support also has a higher stiffness as the two bearing housing is connected over a larger area than would be the case with two individual housings. With such an arrangement, the outer rings of the bearings are more restrained in their movement (see **figure 6**).

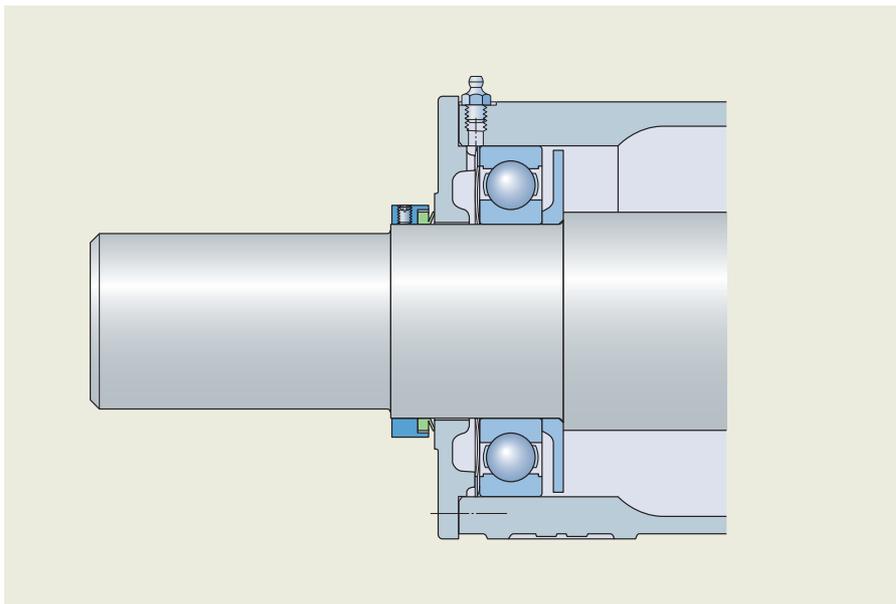
**Fig. 7:** A support ring for a V-ring seal

The support ring has three functions: it keeps the V-ring in place, it works as an extra flinger by forming a gap with the cover of the housing and it protects the V-ring from getting damaged in operation (see **figure 7**). For the recommended dimensions of support rings, see the *SKF bearing housings and roller bearing units* catalogue.

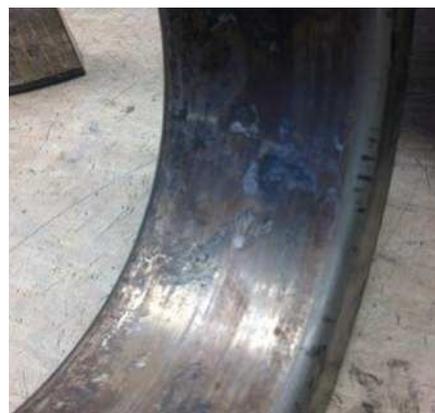
**Fig. 8:** Evidence of ring creep on a bearing inner ring

SKF normally recommends a k6 shaft fit for deep groove ball bearings in these kind of applications. However, I experienced a few cases of creep between the inner ring and the shaft due to relative movement when the k6 fit was at its minimum (see **figure 8**). Consequently, I always use a m5 shaft fit.

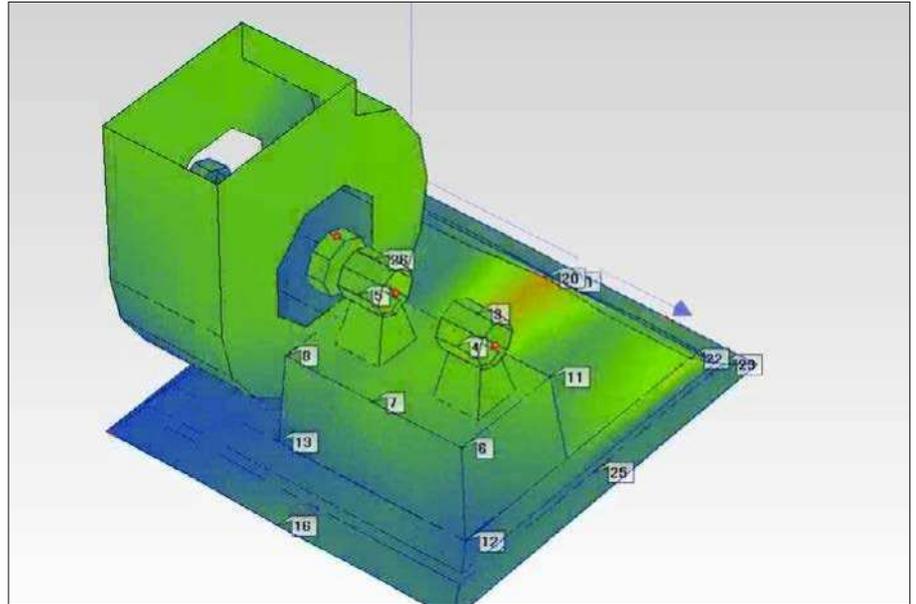
Fig. 9: ODS plot before the rebuild

There was a clear difference in the movement of the bearings before and after the rebuild with the two SNH plummer block housings seen to be moving against each

other (see **figures 9 and 10**). Note that the ambient temperature was different when the two measurements were taken.

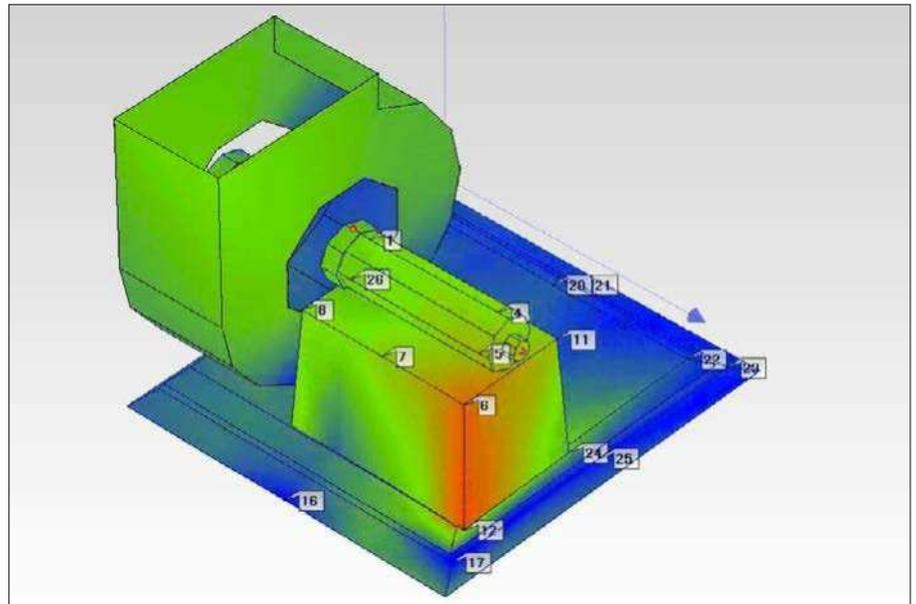
Fig. 10: ODS plot after the rebuild

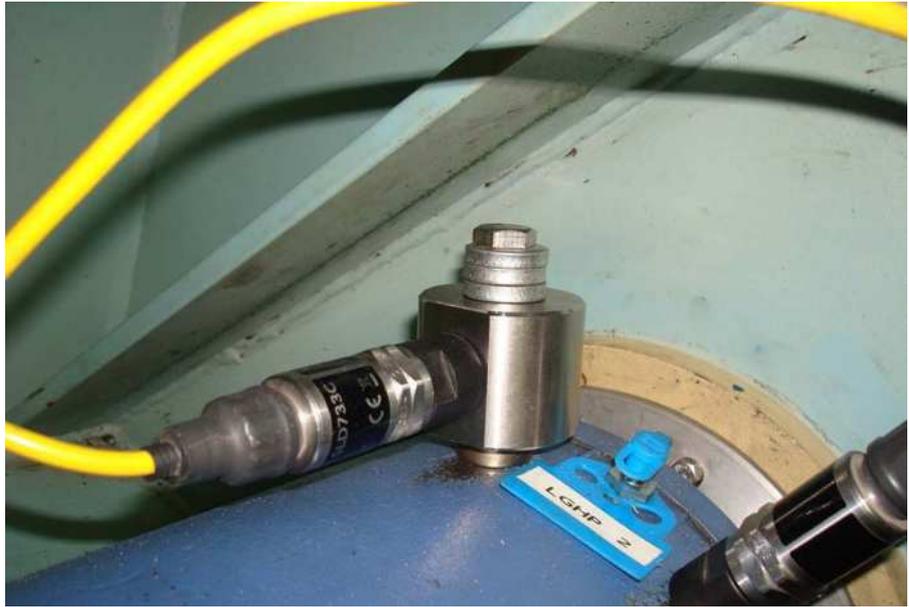
*Fig. 11: Radial sensor placement*

For critical fans in paper mills, I recommend condition monitoring. Ideally, sensors should be mounted in both radial and axial positions as taking measurements in both directions gives a very good overview of what is happening to a bearing (see **figures 11 and 12**). The axial sensor should be mounted on the housing foot if space allows this.

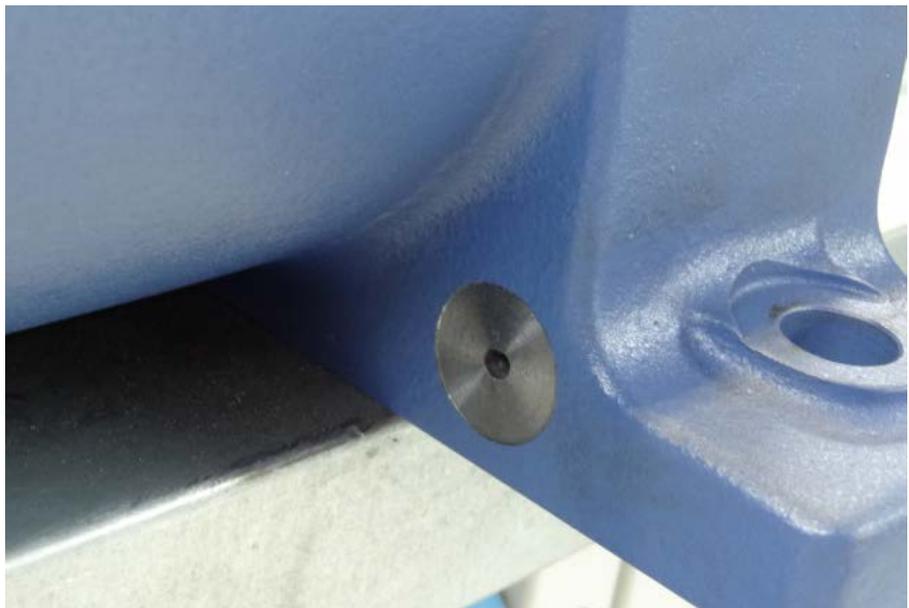
*Fig. 12: Housing foot prepared for axial sensor placement*

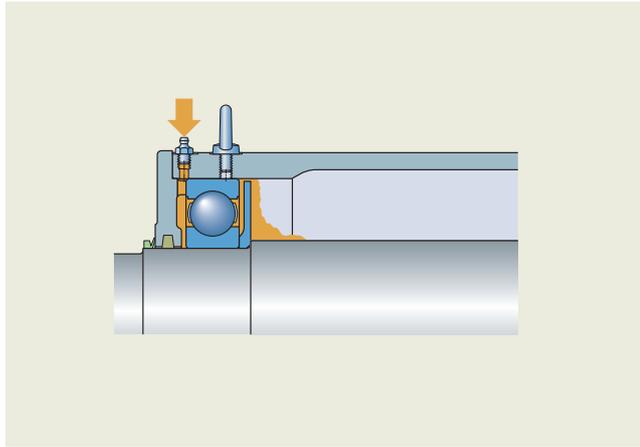
*Fig. 13: Relubricating PDN housings*

The PDN two bearing housings are well designed for relubrication with the bearings at both housing ends. The flinger rings move old grease into the middle of the housings where there is space enough for it to collect (see **figure 13**)

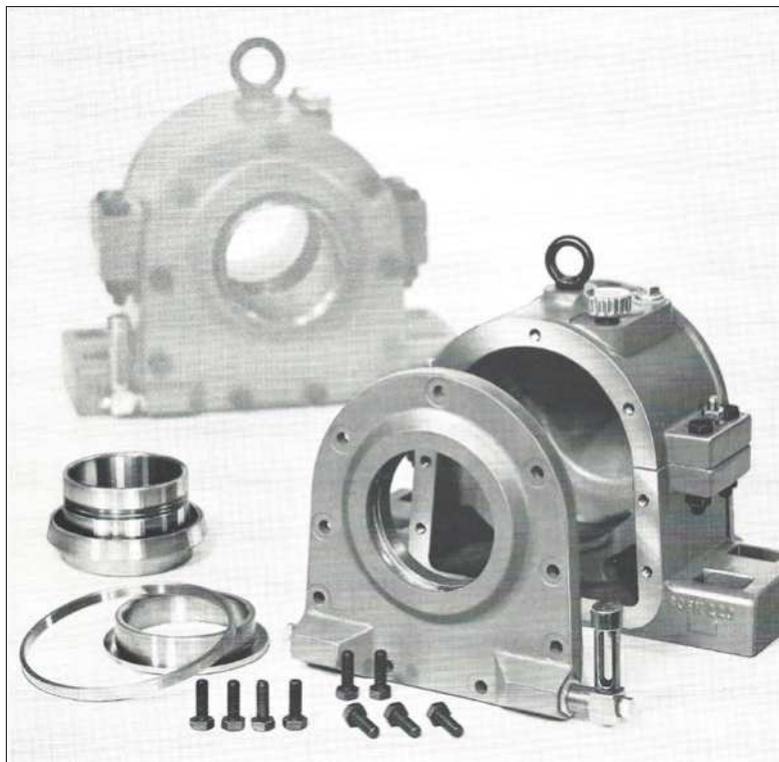
*Fig. 13: SOFN housing*

I did know that the bearing was running at high speed in a hot environment and that it was mounted in an SKF SOFN housing (see **figure 13**). Note that these housings are now mostly replaced by SKF SONL ones (see **figure 14**). Both SOFN and SONL housings have pick-up rings that hang loosely on a sleeve on the shaft on one side of the bearing and contact the oil bath in the lower half of the housings (see **figure 15** where the ring is shown with a red circle). When the shaft rotates, the ring follows and transports oil to a collecting groove to allow the lubricant to get to the bearing. This allows higher speeds than would be possible with standard oil bath or grease lubrication. Furthermore, the oil in the housing can be cooled though it wasn't in this case.

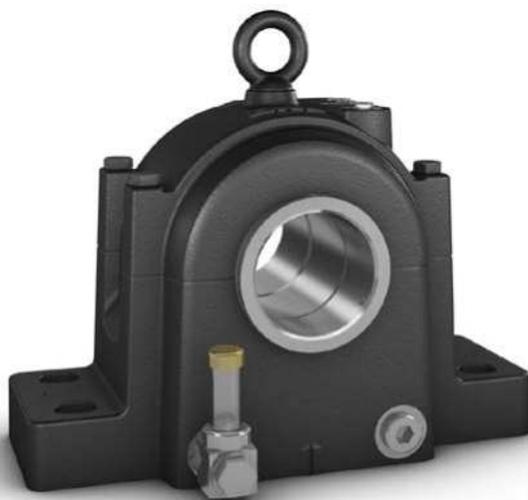
*Fig. 14: SONL housing*

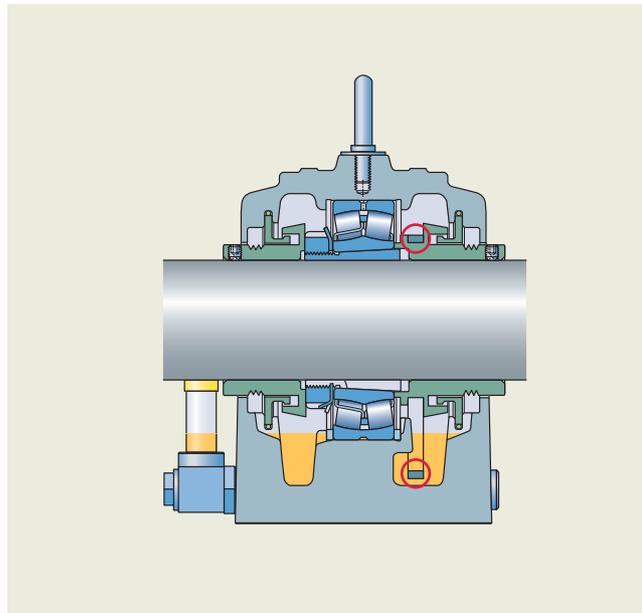
*Fig. 15: Cut through of a SONL housing*

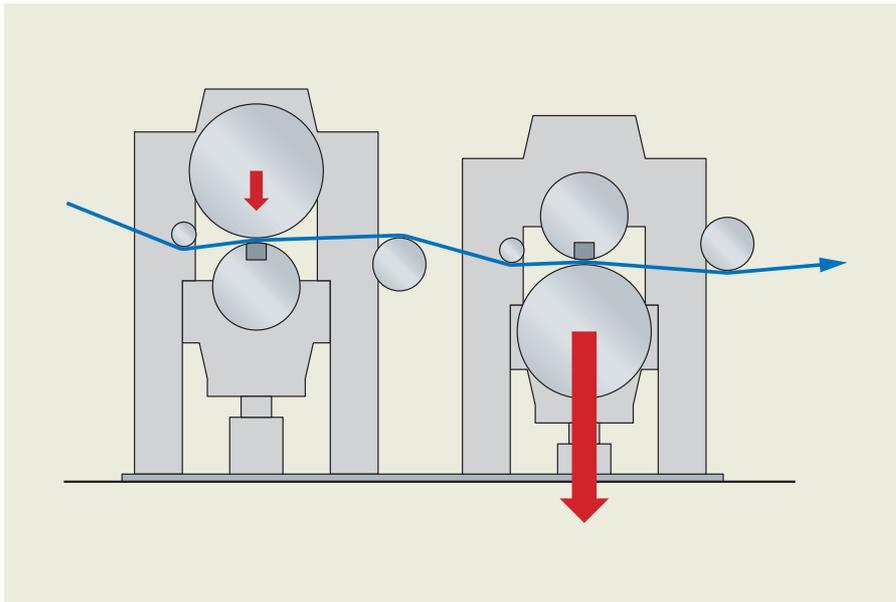
**Fig. 16:** Soft calender. The red arrows show load on the main bearings

**1** The bearing might need to be used in another application where the full load capacity is required. This can be the case on soft calenders, for instance, where rolls can be mounted either in the upper or the lower position. When in the upper position, the NIP load reduces the load on the bearings whereas in the lower position, the NIP load increases it (see **figure 16**). As the rolls are stored with the bearings mounted on them, it's best to use bearings with full load capacity which are able to run without smearing between rollers and raceways when the loads are too low. In such cases, SKF recommends the NoWear coating on the rollers as it has been proven to eliminate smearing in soft calenders.

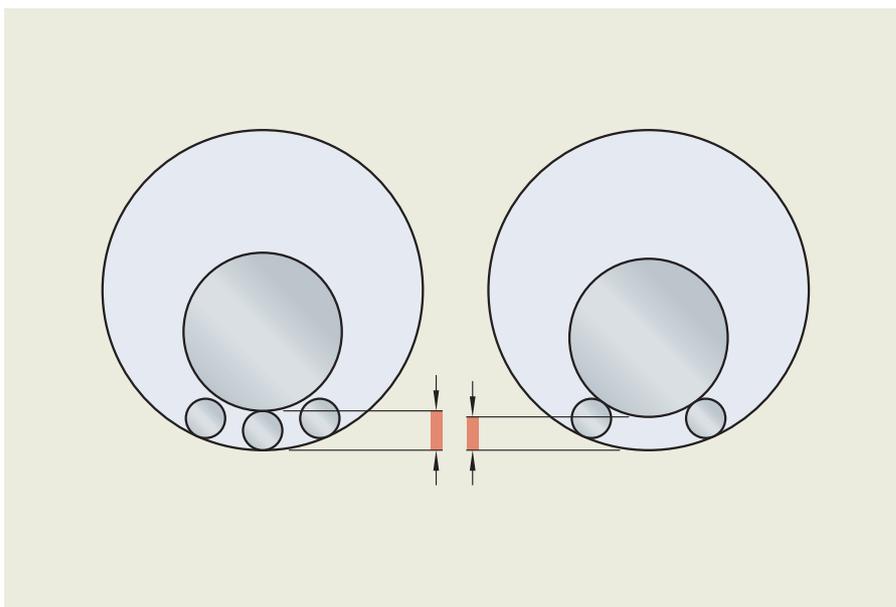
**Fig. 17:** The number of rollers and radial internal clearance have an influence on total radial run out

**2** **Figure 17** shows, in a very exaggerated way, that total radial runout on a bearing also depends on the distance between two rollers and the internal radial clearance. The inner ring on the right will move up and down a greater distance than the one on the left when the bearing is rotating.
