Fulfilling promises and responding to questions

In this issue of *SKF Pulp & Paper Practices* I will address a number of different issues:

SKF Global Pulp & Paper
Segment

PUB 72/S9 11147/14 EN · September 2015

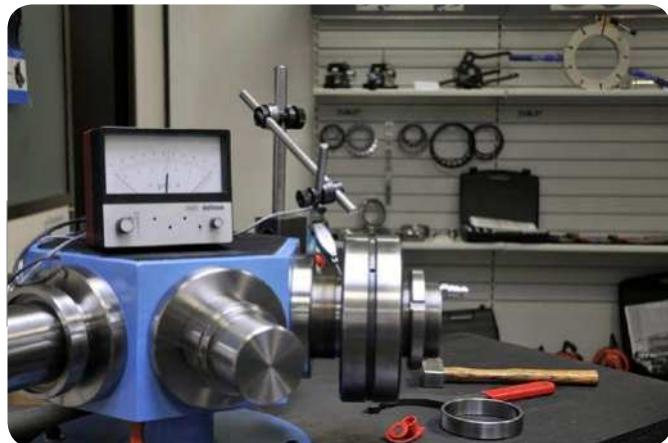
Fig. 2 Bearing position after being slammed into place

Next, I tried the hands on approach with a 22320 EK bearing. First, I slammed the bearing on to its tapered seat and used a micrometer set to zero as the reference (\rightarrow figure 2). This is the right position for the Prussian blue method for a bearing of this size and it can easily be removed by hand. Then I positioned the bearing with the nut and hammer plus sound method (\rightarrow figure 3). The bearing was driven-up further and needed to be gently hammered to dismount it, but the distance was less than 0,08 mm even after three attempts. Finally, a hydraulic nut was used to position the bearing (\rightarrow figure 4). The idea was to measure the oil pressure when the bearing was in the slam position and then again in the sound position and to note the position of the bearing with the calculated pressure.
